PRESERVATION PLANNING REPORT

**109 EAST ATLANTIC AVENUE
HADDON HEIGHTS, NEW JERSEY**

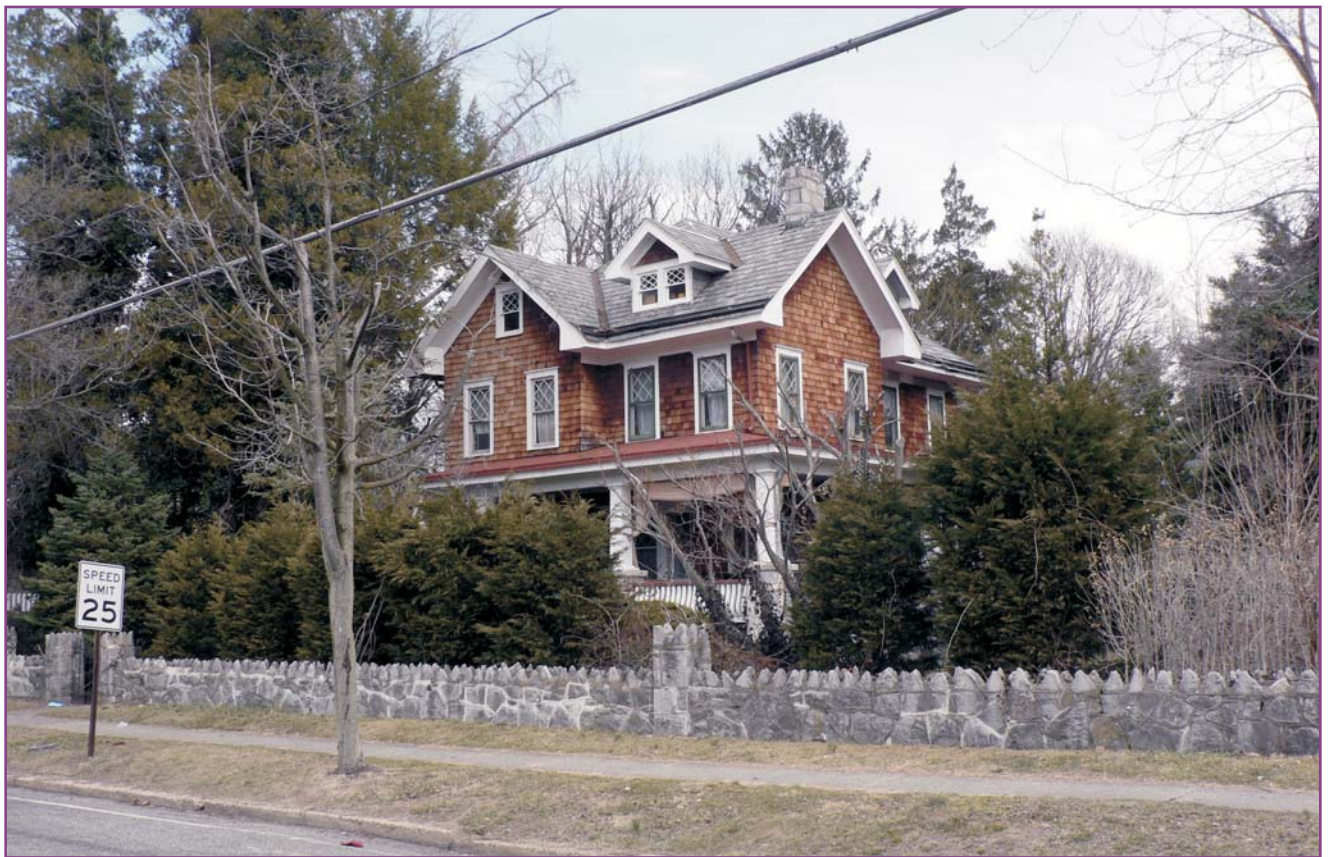
Photograph 1 of 46. View of 109 East Atlantic Avenue from the south showing the 2½ story shingled and sided frame building with slate roof and wrap around porch. Built circa 1913, the house is surrounded by overgrown vegetation that prevents full visibility.

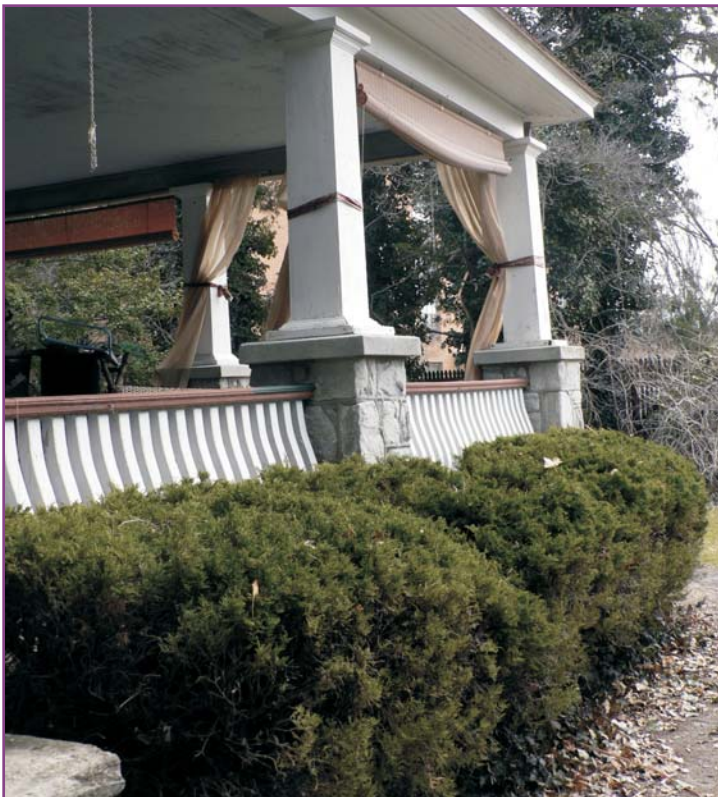
Photograph 3 of 46. View along front porch showing proximity of overgrown bushes that hold moisture against the porch's stone foundations. These bushes need to be pruned.

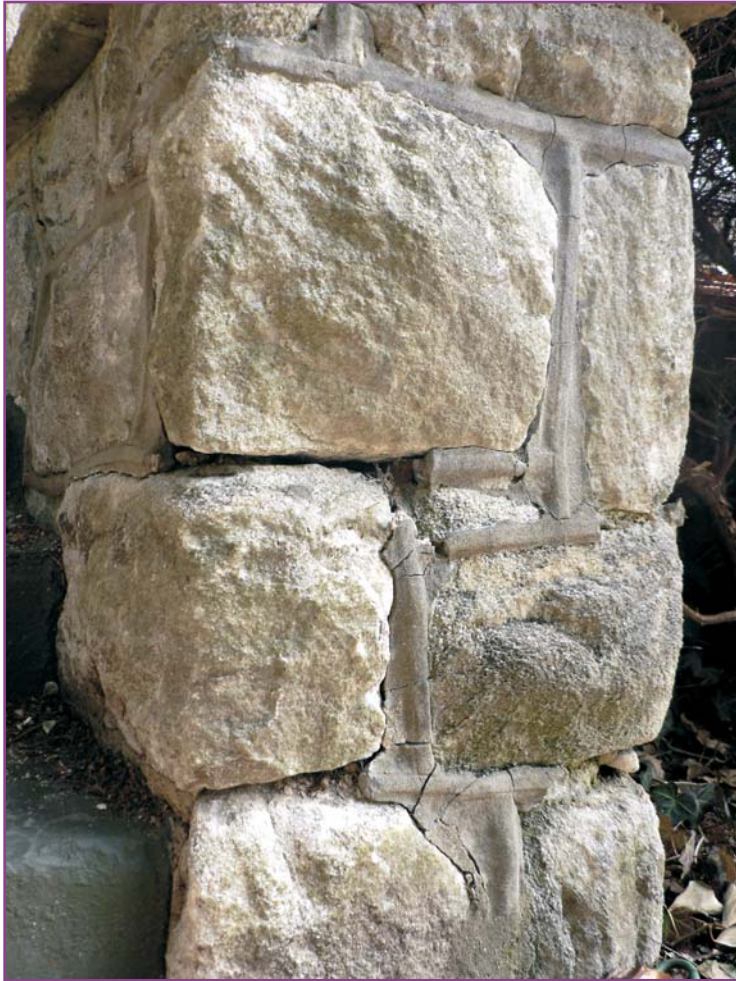
Photograph 4 of 46. Detail of southern cheek wall at front steps showing masonry movement in response to deteriorated mortar joints. Repair and spot repointing is required.

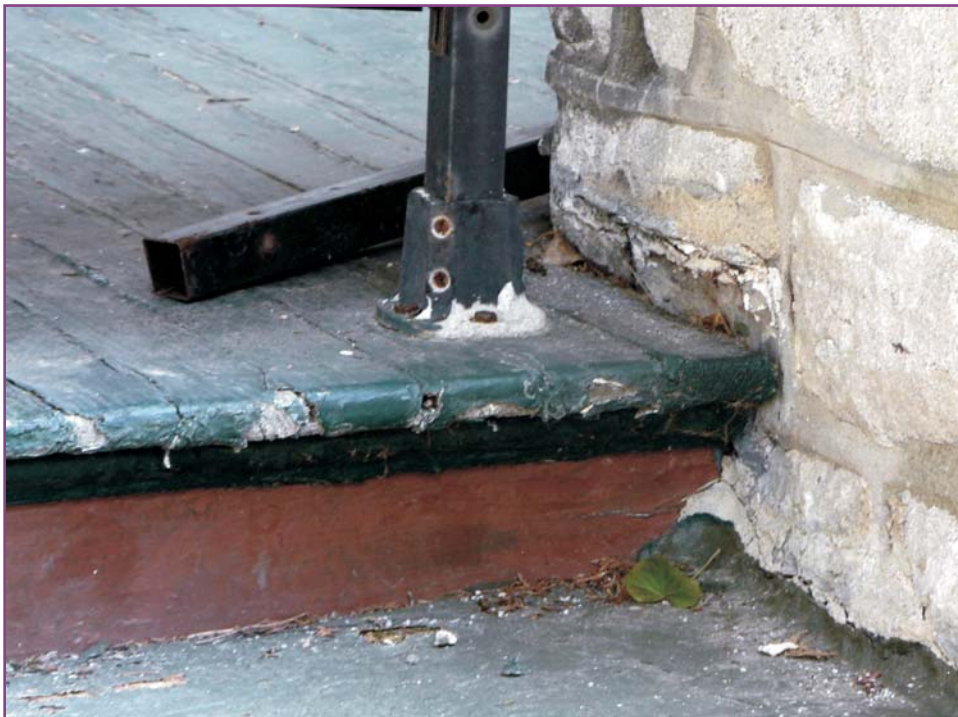
Photograph 5 of 46. Detail of front porch steps at porch pier showing settlement and structural movement. Stabilization of the floor framing will be necessary.

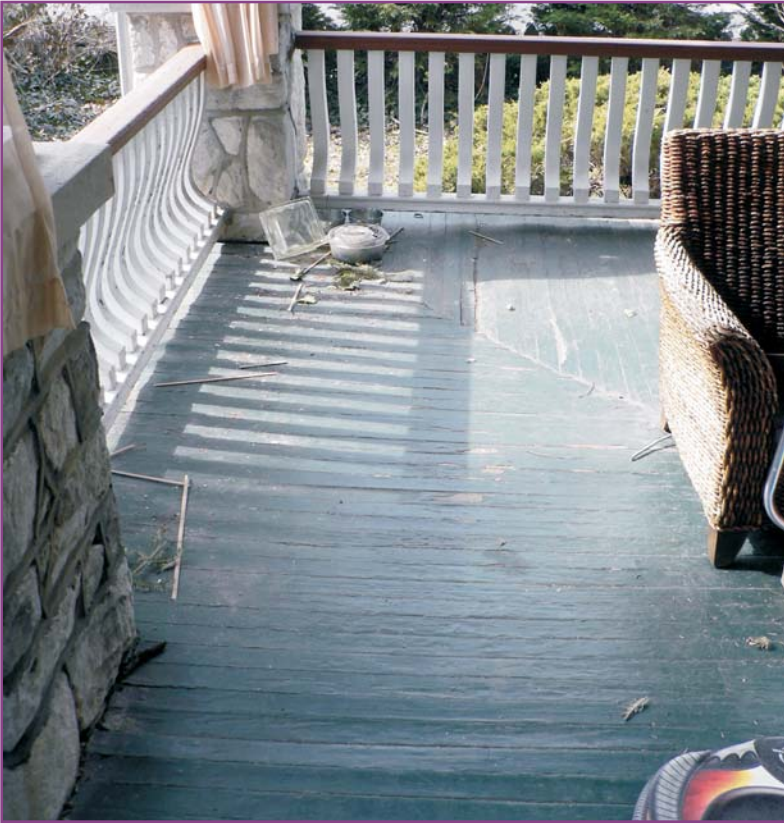
Photograph 9 of 46. Detail of southern corner of front porch floor showing depression at failed floor framing. This framing will need to be stabilized.

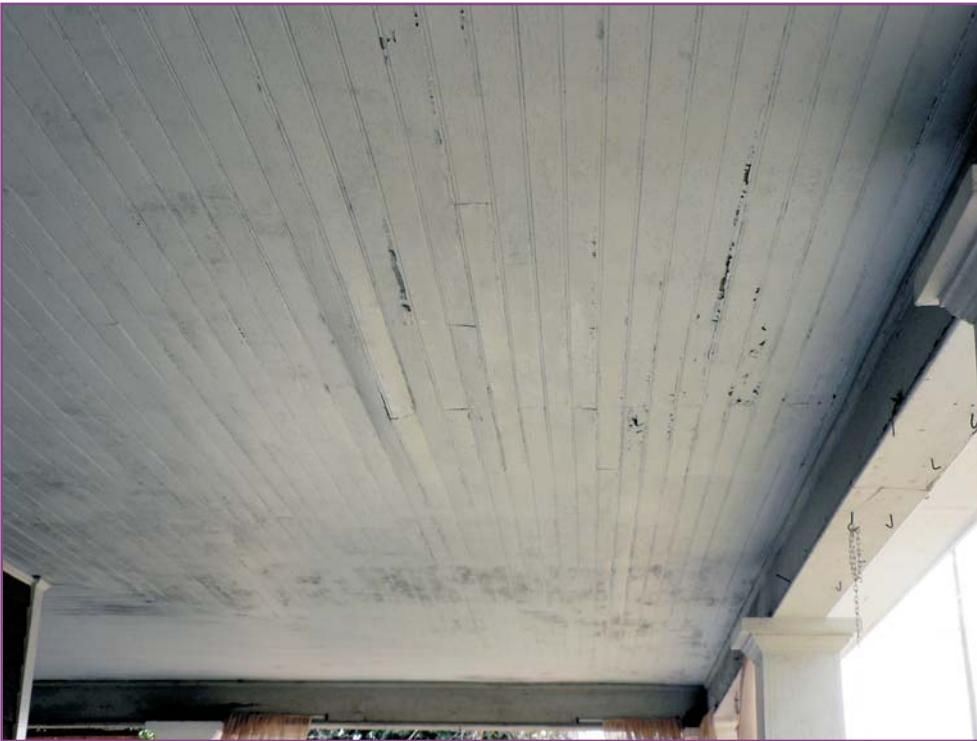
Photograph 10 of 46. Detail of front porch's beaded board ceiling showing buckled board and peeling paint at small leak.

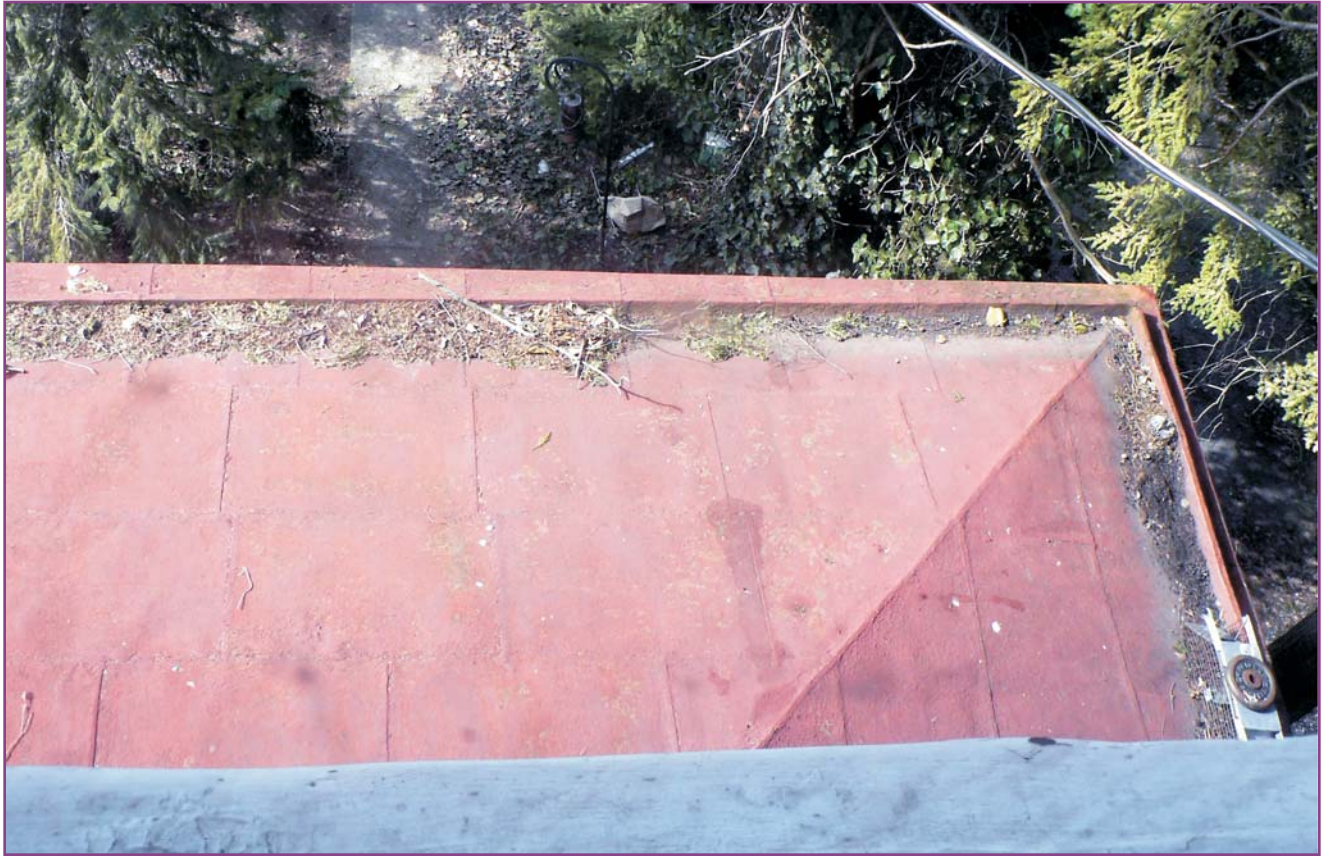
Photograph 11 of 46. View of the porch roof from the attic window. This roof is covered with flat seam metal (terne-plated steel, commonly called tin) that will last forever provided it is kept painted. The “tinner’s red” color is historically appropriate. Note that the pole gutters need cleaning.

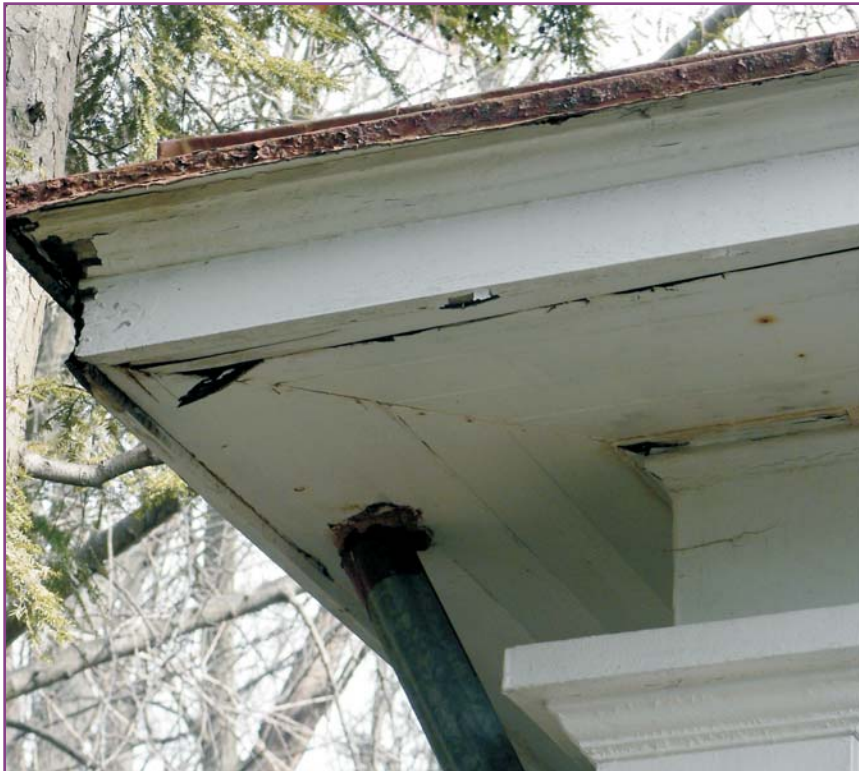
Photograph 12 of 46. Detail of western corner of front porch soffit showing minor woodwork deterioration and failing paint on rusting drip edge.

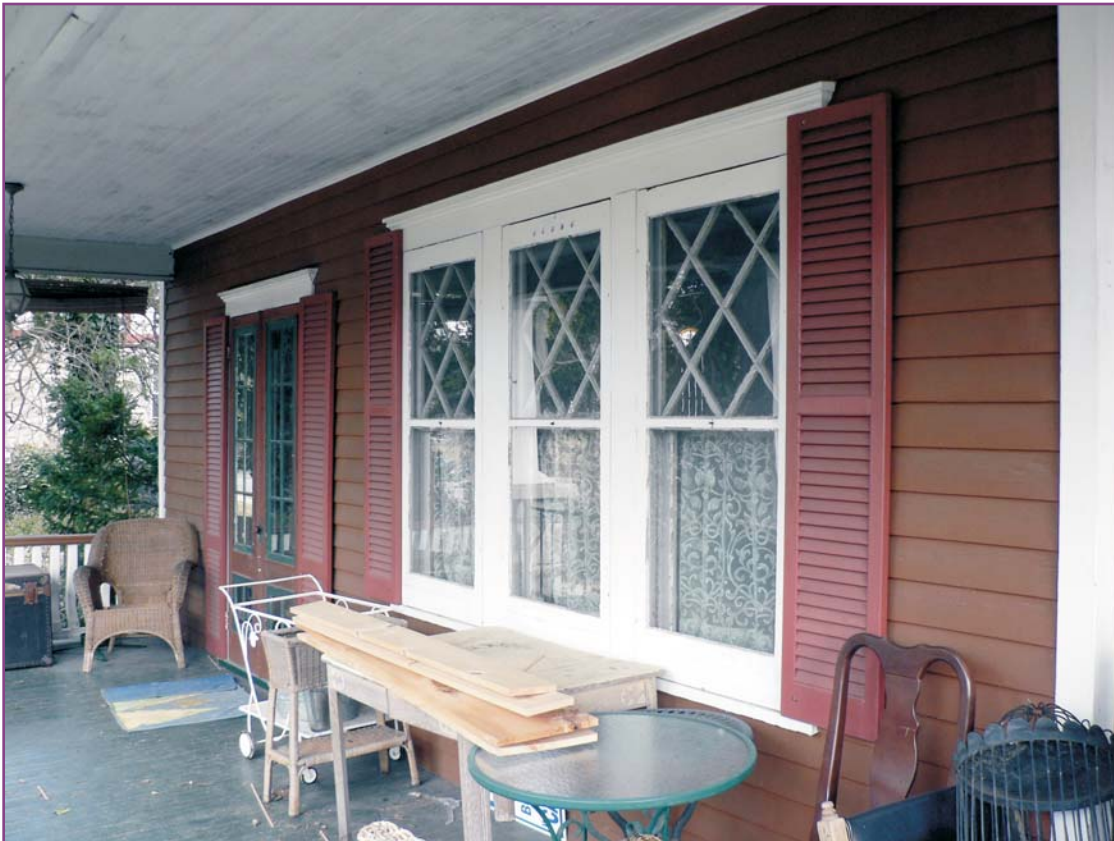
Photograph 13 of 46. View of first floor front facade inside porch showing original paired beveled glass door opening and original tripartite twelve-over-one sash window. Note that this original first floor clapboard has been painted, unlike the unfinished replacement shingles at the second floor level. The plastic shutters should be removed to facilitate maintenance of the wall surfaces behind them.

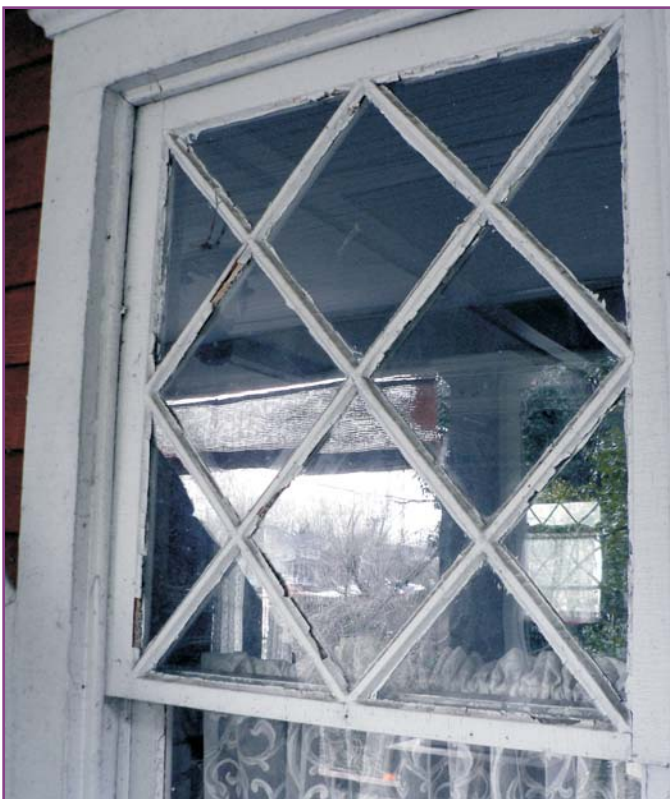
Photograph 14 of 46. Detail of typical first floor original window sash showing missing glazing putty and deteriorating paint. The woodwork of the windows is in excellent condition and will last indefinitely if kept painted. None of the original window sash should be replaced.

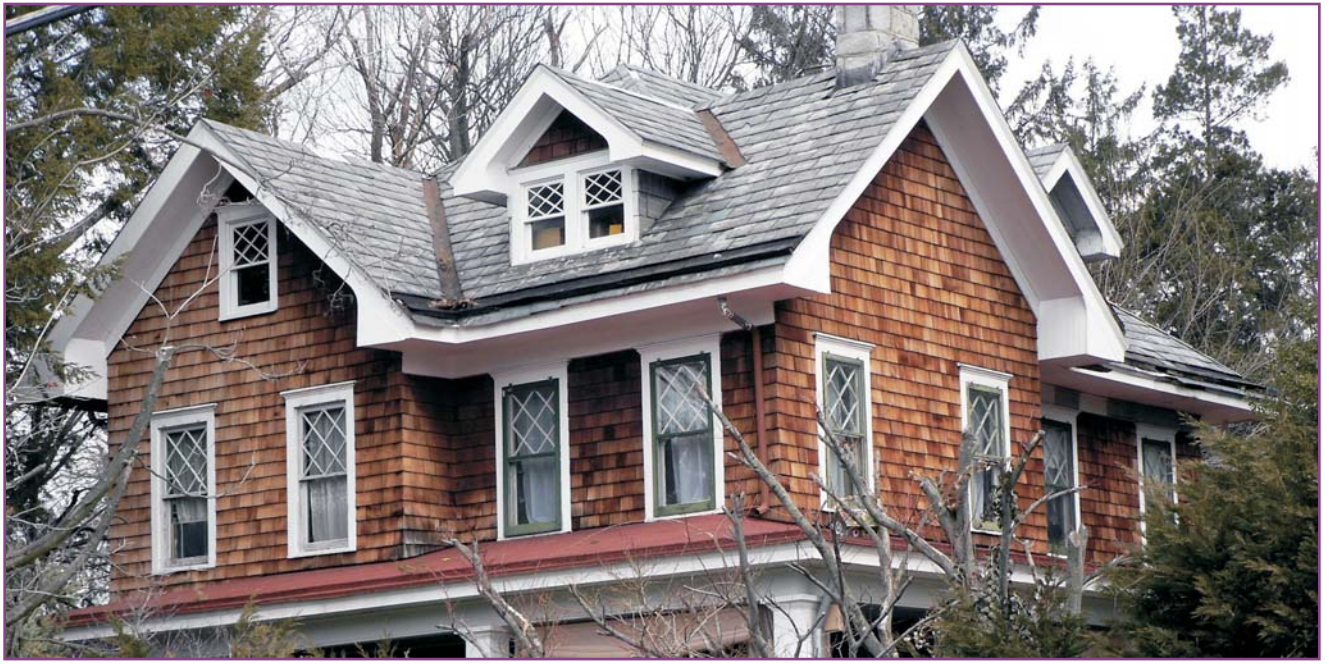
Photograph 15 of 46. View of the house's main roof from the south showing a hipped roof over the Modified American Four-Square plan building with a projecting cross-gable on the front western corner and an unfenestrated cross-gable on the side southern corner. Note the paired 12/1 sash in the gabled dormers and the pole gutters above the closed soffits, all original building features.

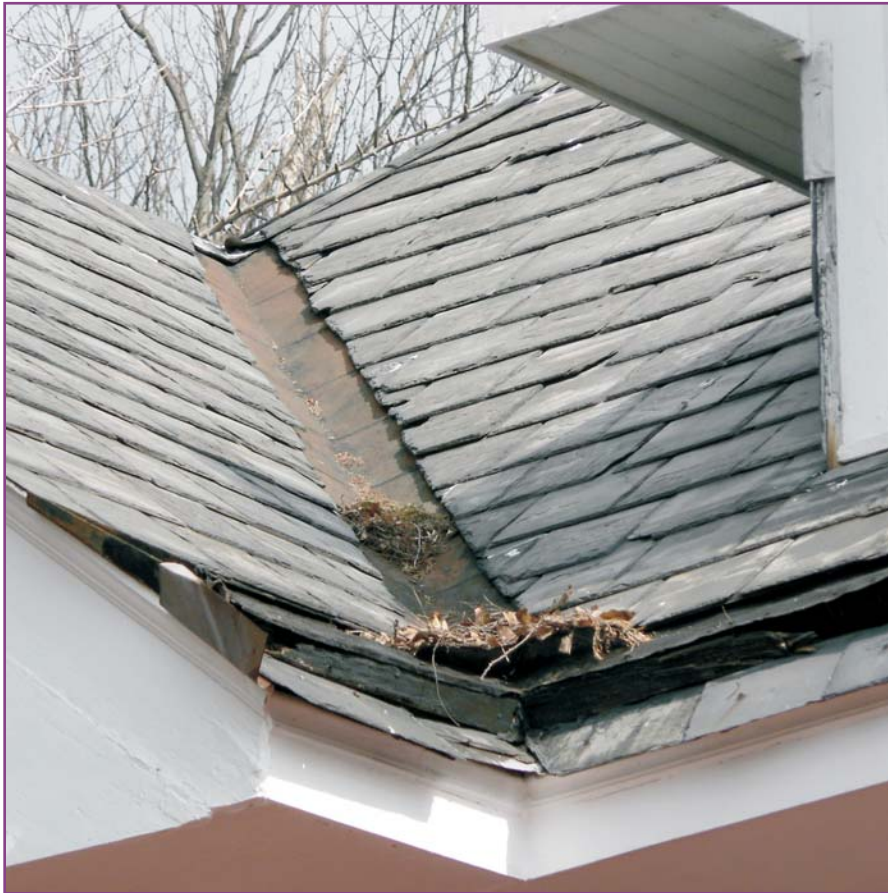
Photograph 16 of 46. Detail of front roof valley showing rusting of the valley flashing, due to lack of maintenance (paint). Note debris and leaves collected at pole gutter.

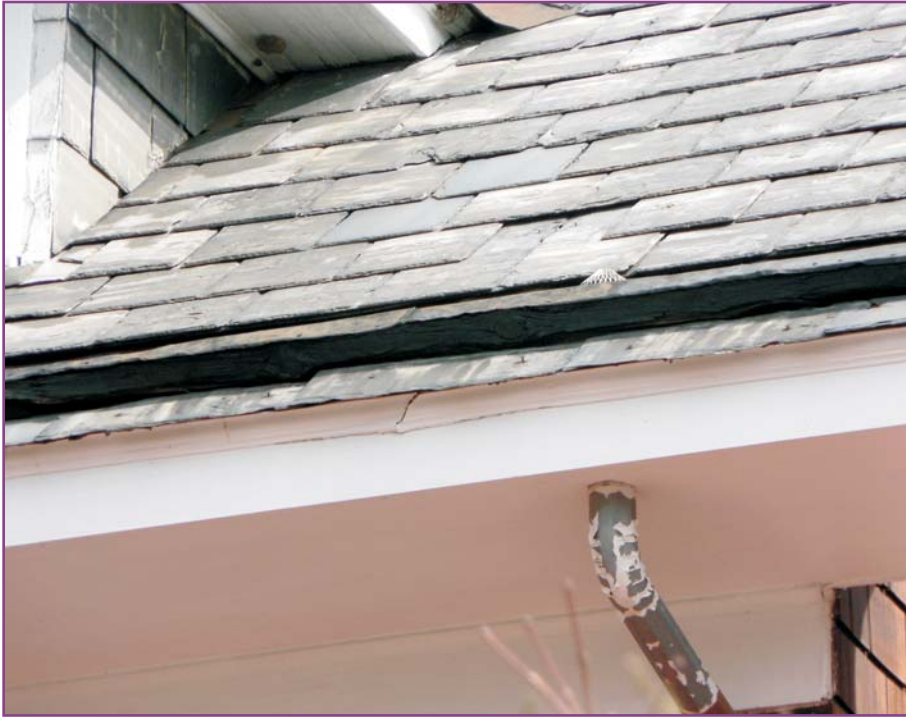
Photograph 17 of 46. Detail of front roof slope showing properly repaired as well as missing slates, rusting pole gutter and downspout, and original slate dormer cheeks which should not be removed when the roof is replaced (because they are sound and will provide evidence of the original roof covering long after it is gone.)

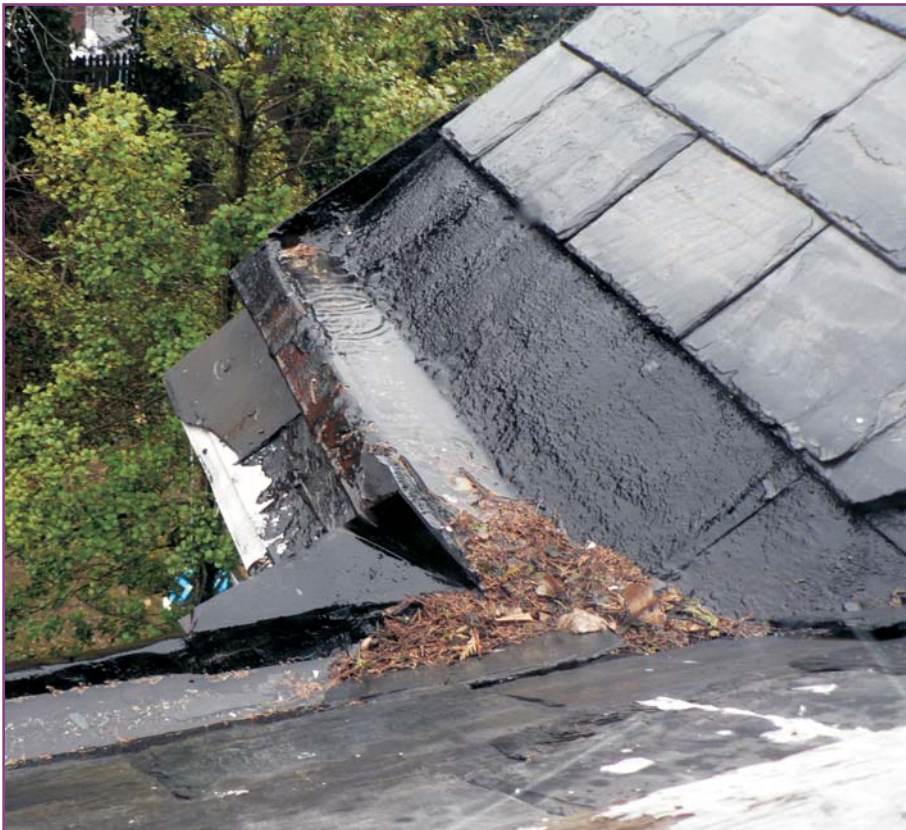
Photograph 18 of 46. Detail of slate condition on southeastern side roof as seen from attic window. Note water running over the top of the clogged pole gutter causing deterioration to the woodwork of the cornice below.

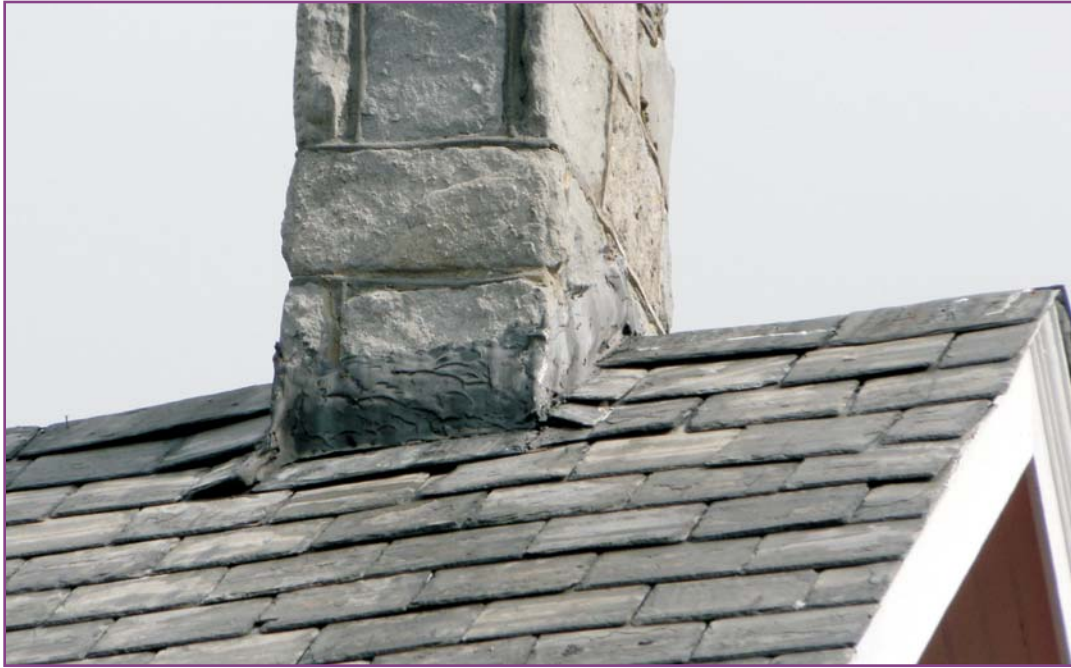
Photograph 19 of 46. Detail of the main chimney at the junction with the front roof slope showing a lack of proper flashing. The original flashing was apparently tin and deteriorated from a lack of re-painting. It appears to have been covered with bitumen (which is incompatible with tin) and allowed further moisture infiltration.

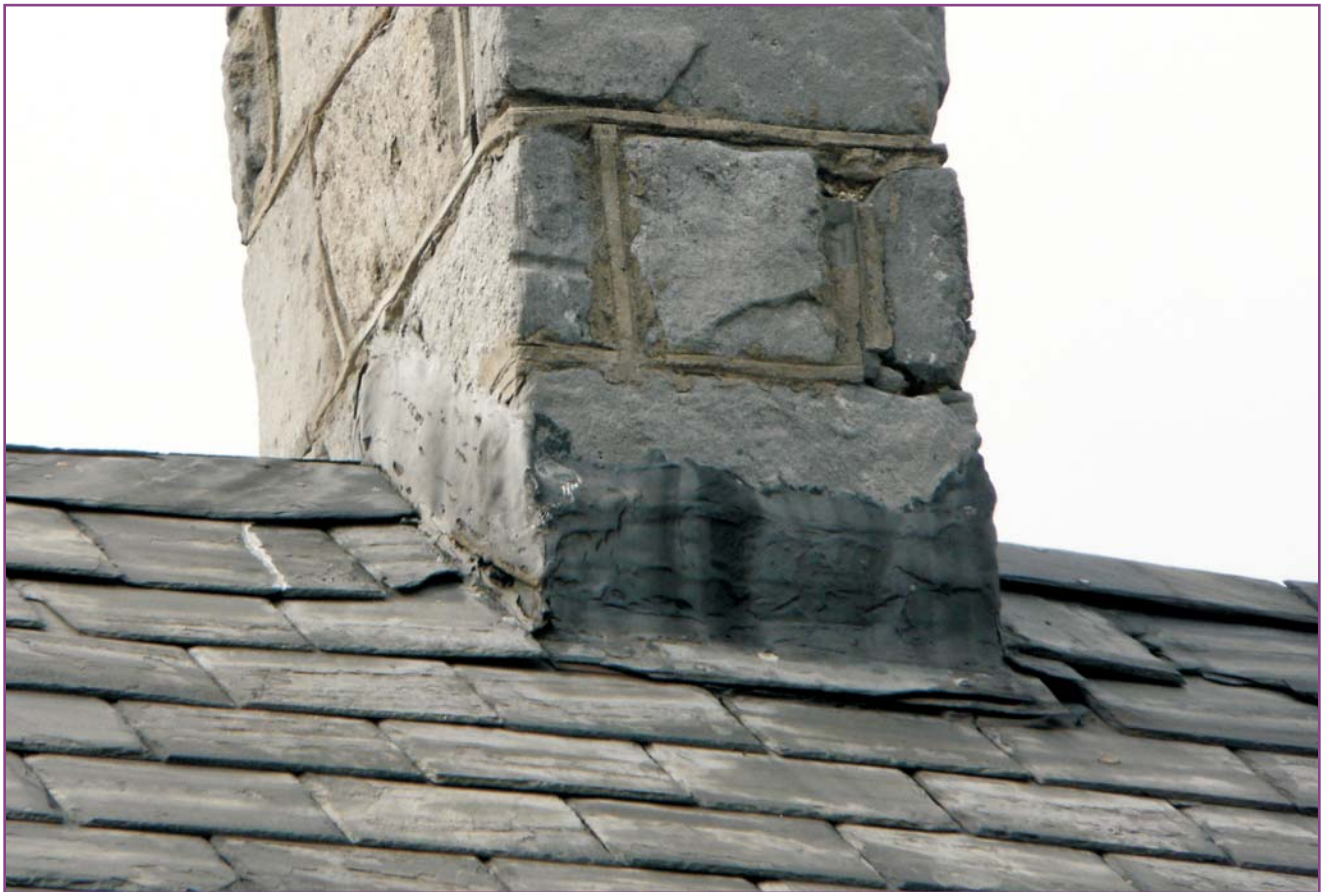
Photograph 20 of 46. Detail of the junction of the main chimney and the rear roof slope showing bitumen-coated flashing and need of spot repointing of the masonry.

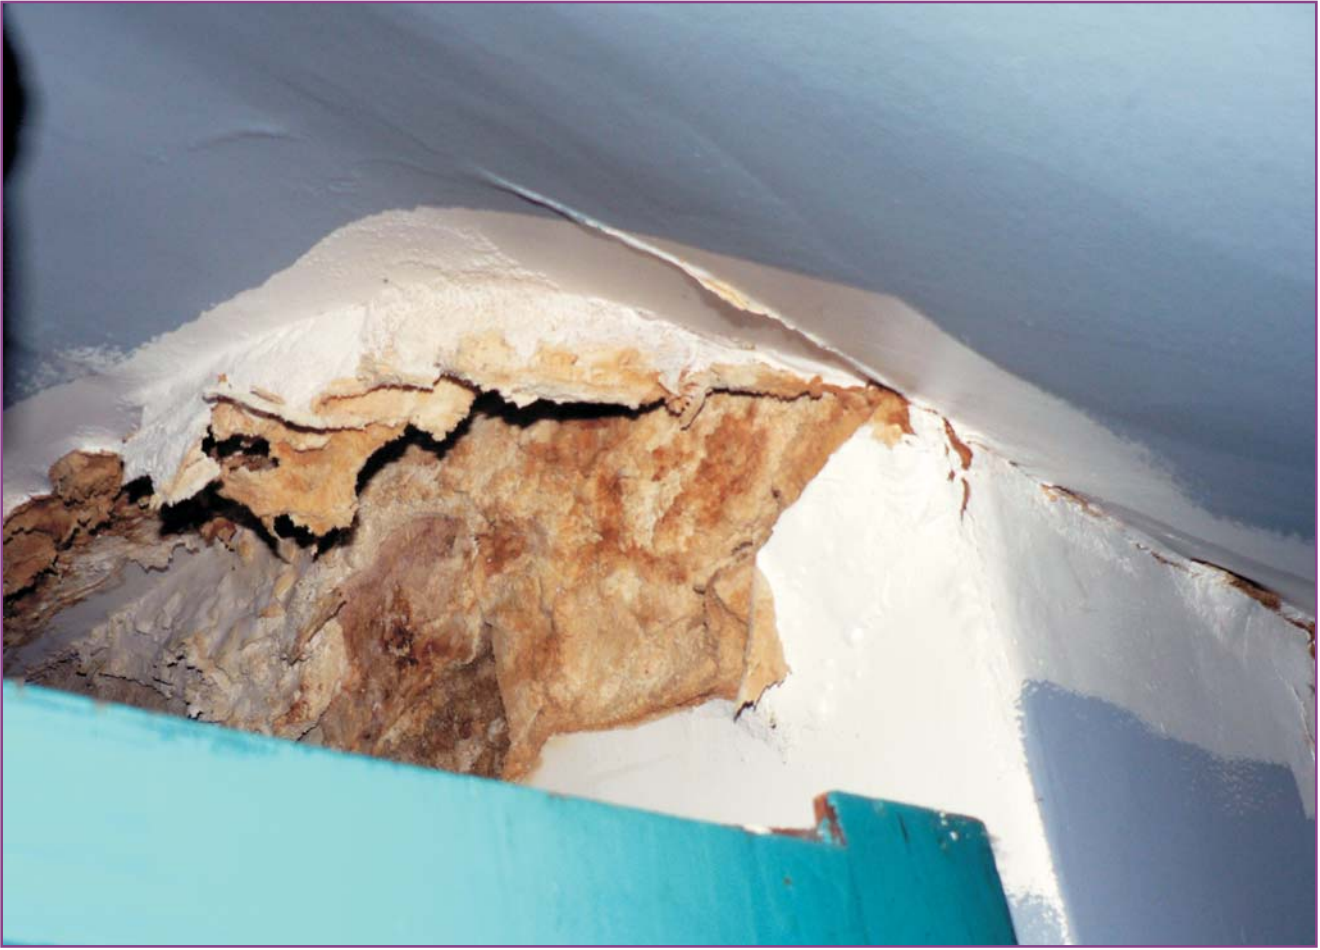
Photograph 21 of 46. Detail of damaged plaster on chimney wall, directly below roof structure and attic ceiling.

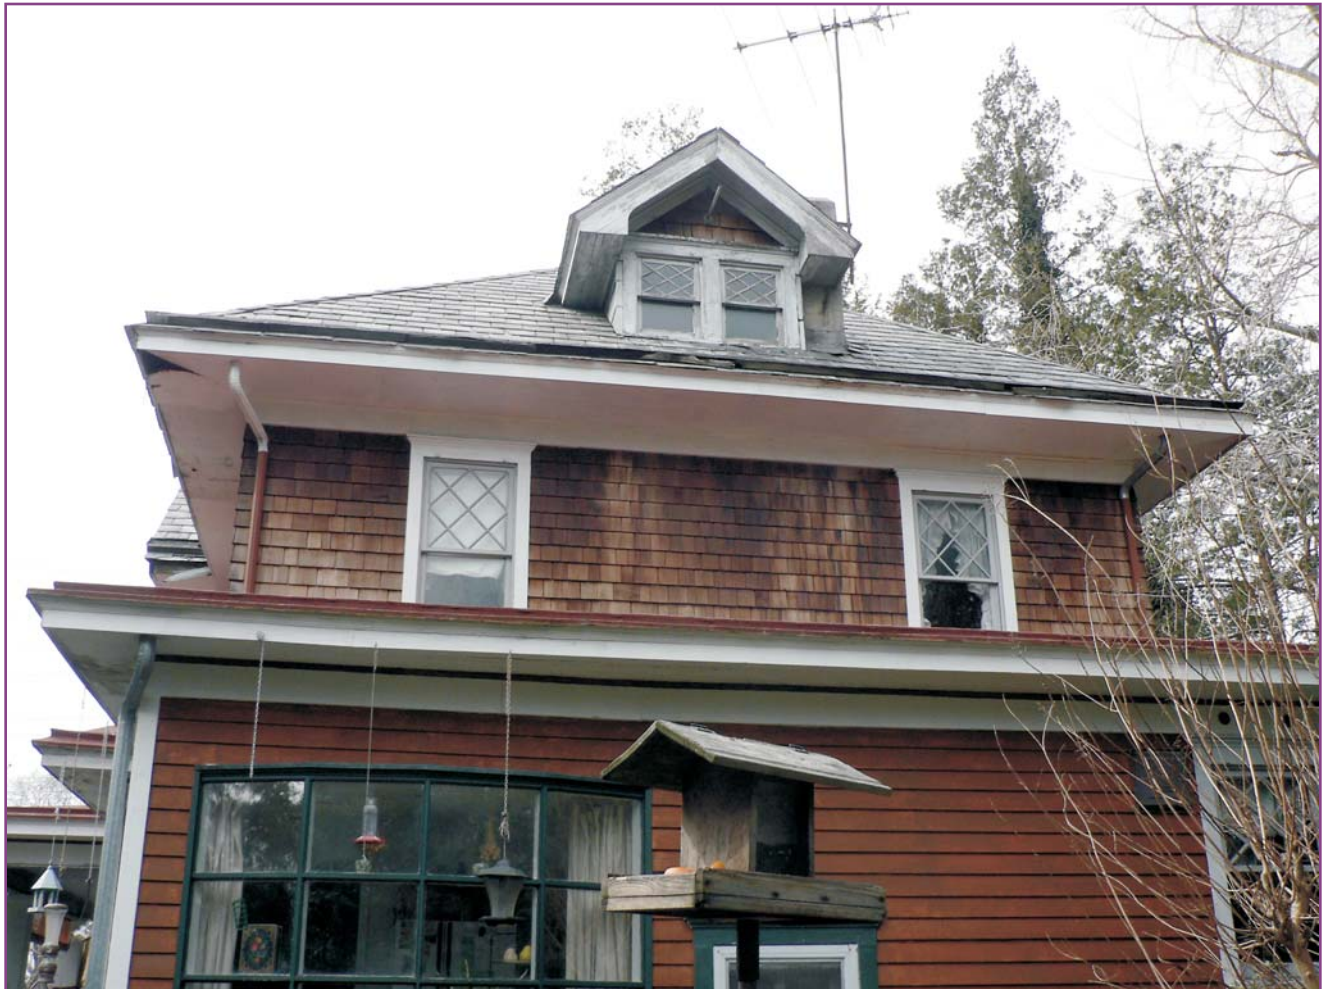
Photograph 22 of 46. View of the rear elevation showing the hipped roof main section with gabled dormer, shingled second floor wall with two twelve-over-one sash windows, and projecting one-story rear wing with shallow hipped roof, added multi-light window, and head of basement door. This is the only side of the house not obscured by overgrown vegetation.

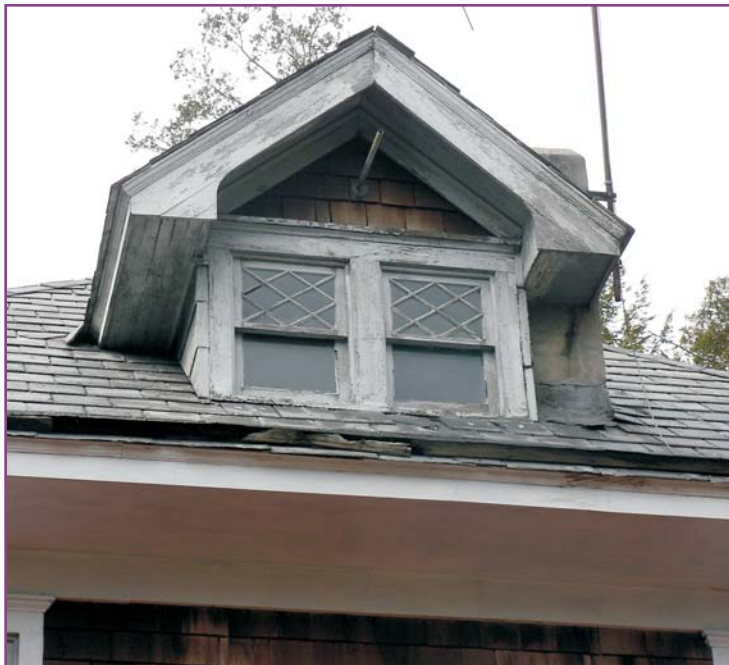
Photograph 23 of 46. Detail of rear dormer and pole gutter, both in need of repair. Note the secondary chimney to right of dormer that vents the basement water heater.

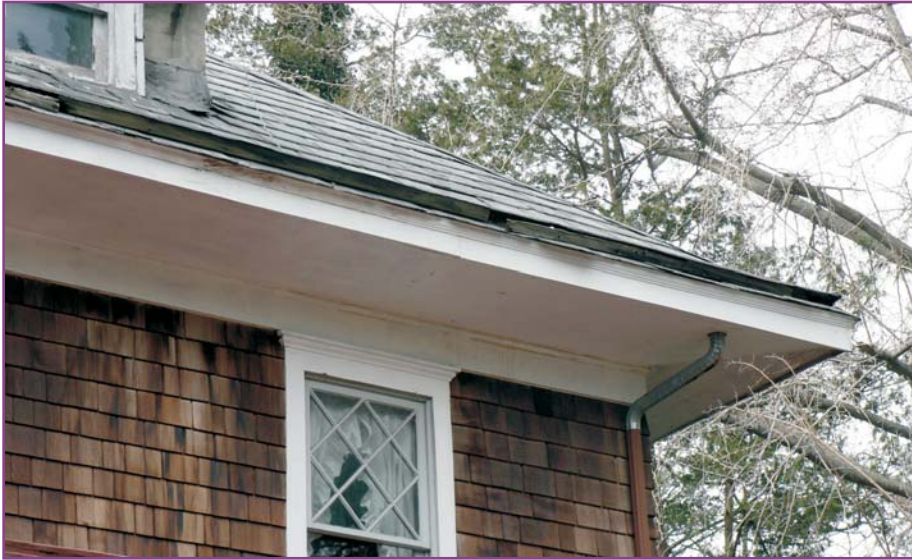
Photograph 24 of 46. Detail of the northwestern end of the rear elevation's roof showing the deteriorated pole gutter.

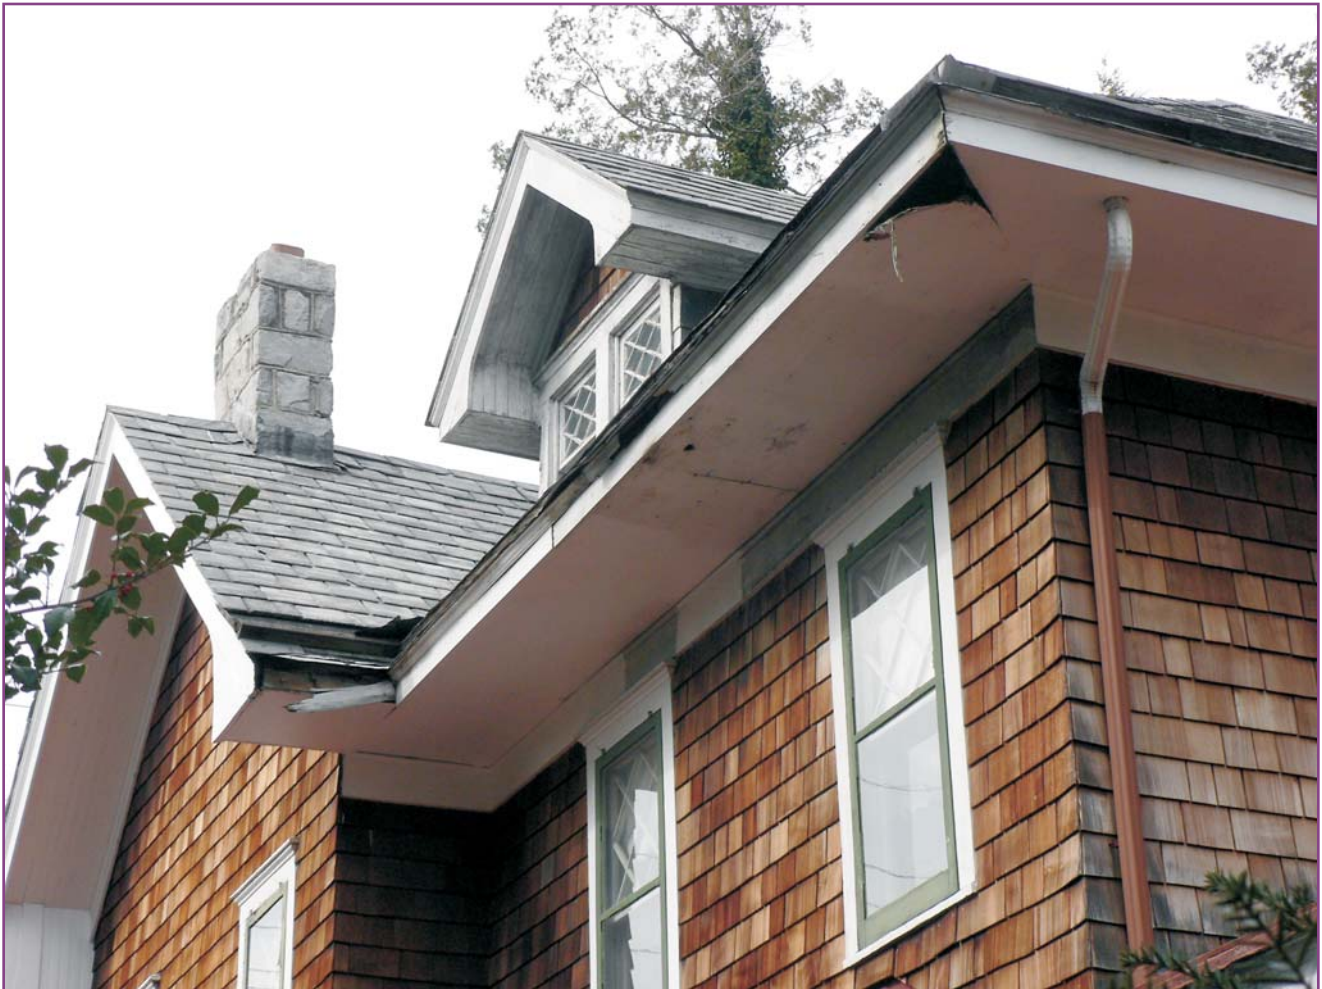
Photograph 25 of 46. View of the soffits and side cross-gable of the southeast elevation, viewed from the rear yard. Note hole in soffit.

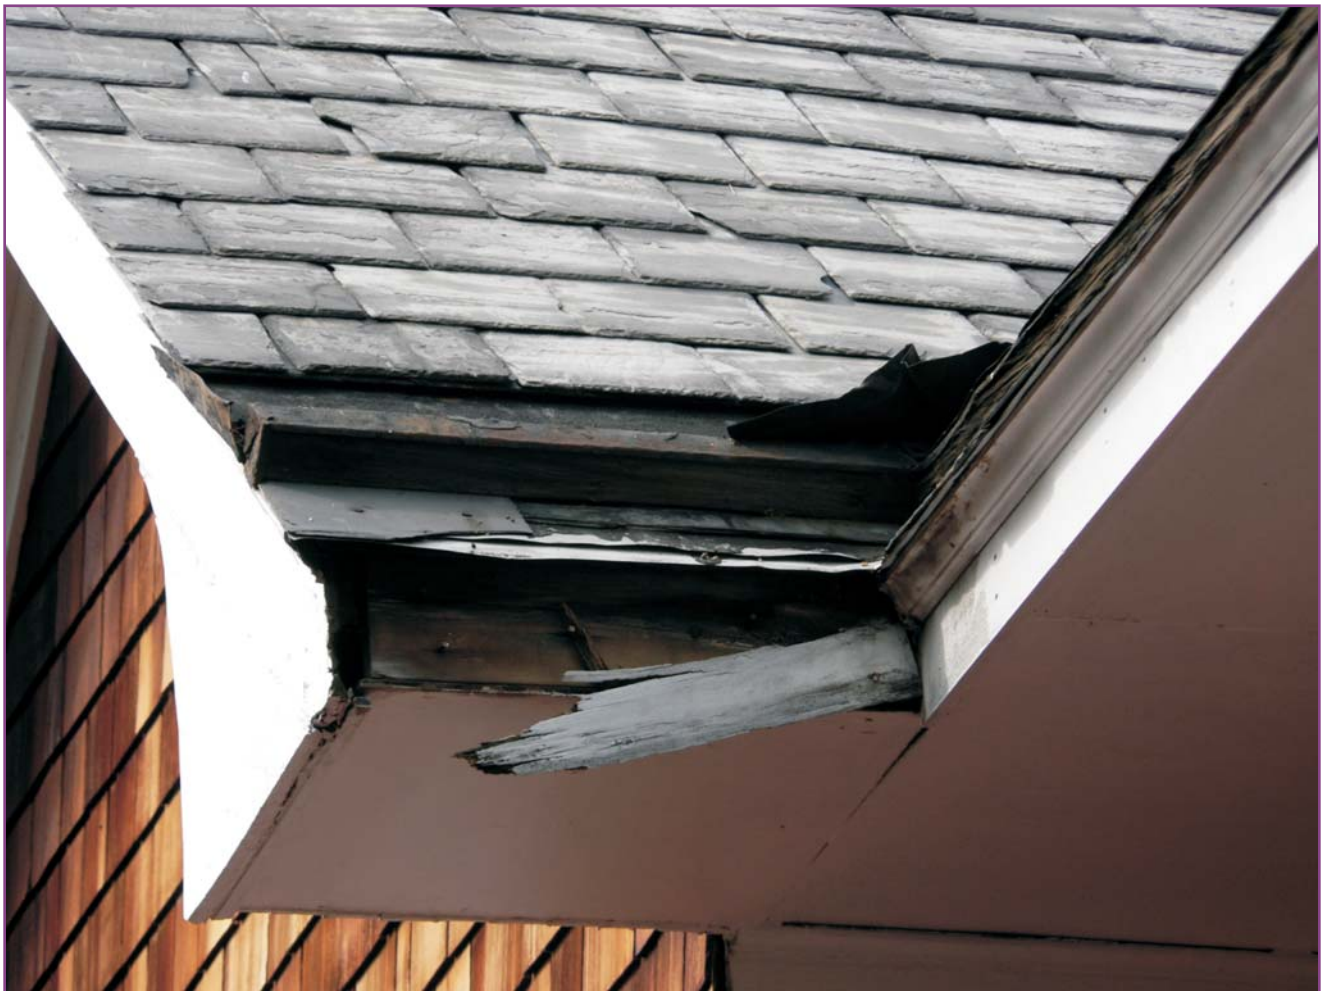
Photograph 26 of 46. Cornice/soffit detail on the southeast elevation (Stanfill Towers side) showing deterioration of the roof slope beneath the pole gutter, loose fascia, and missing cornice woodwork. This is the same area shown in Photograph 18, taken from the attic window, above.

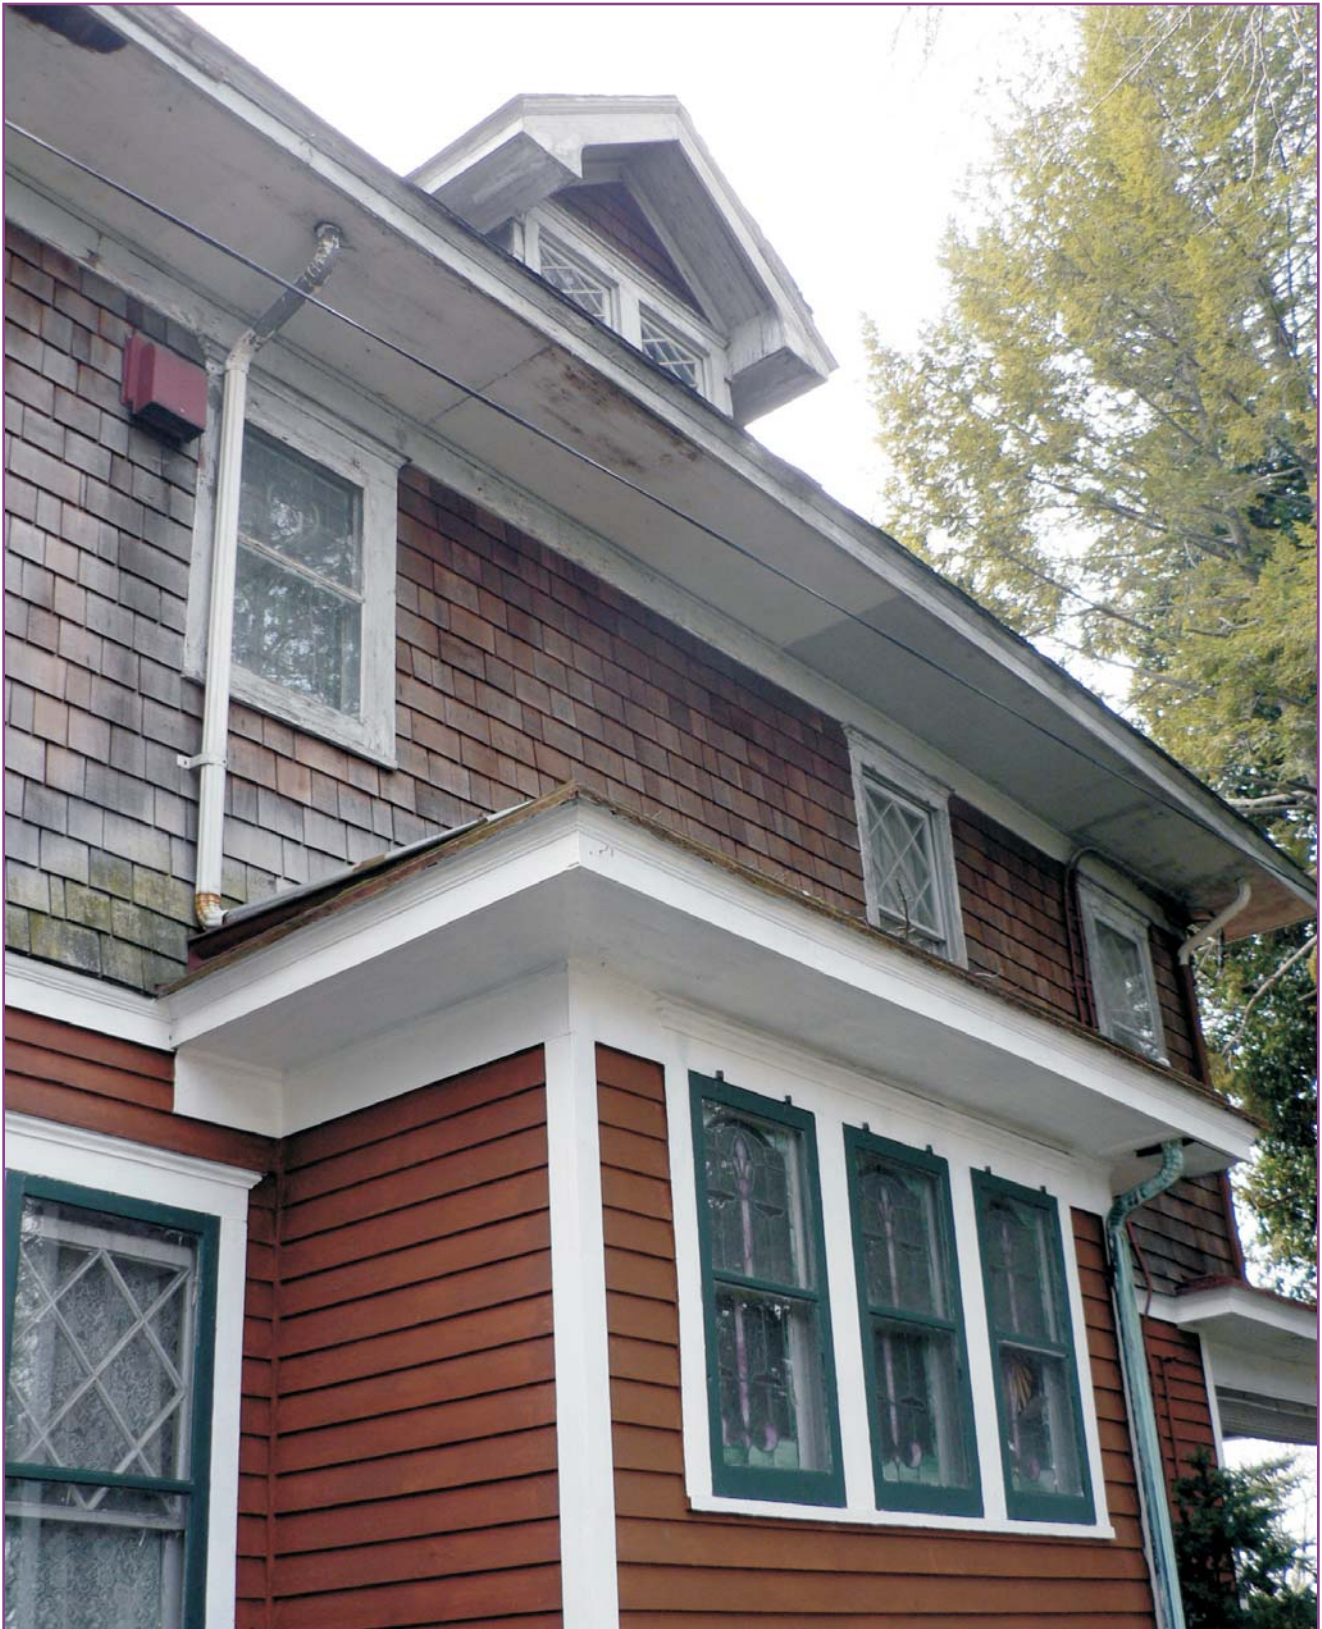
Photograph 27 of 46. View of northwest elevation (driveway-side wall) at box bay of stair landing showing failure of the downspout where it meets the bay's roof and broken stained glass in far first-floor window. (Also shown from the interior in Photograph 46.)

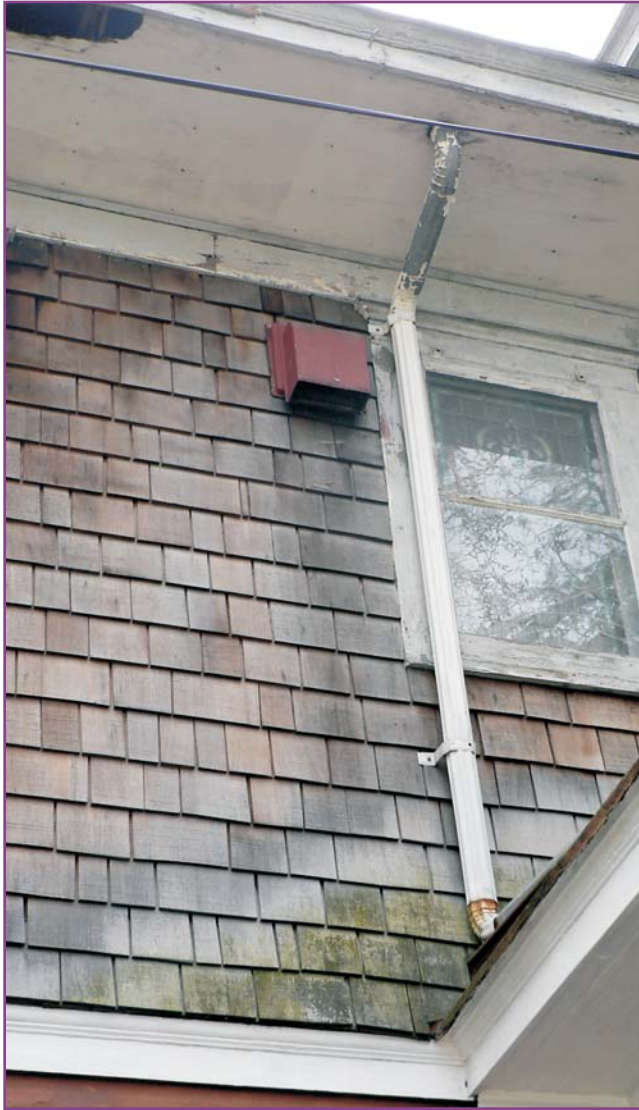
Photograph 28 of 46. Detail of the downspout failure showing organic growth on the wall shingles due to excessive dampness.
