PRESERVATION PLANNING REPORT

**109 EAST ATLANTIC AVENUE
HADDON HEIGHTS, NEW JERSEY**

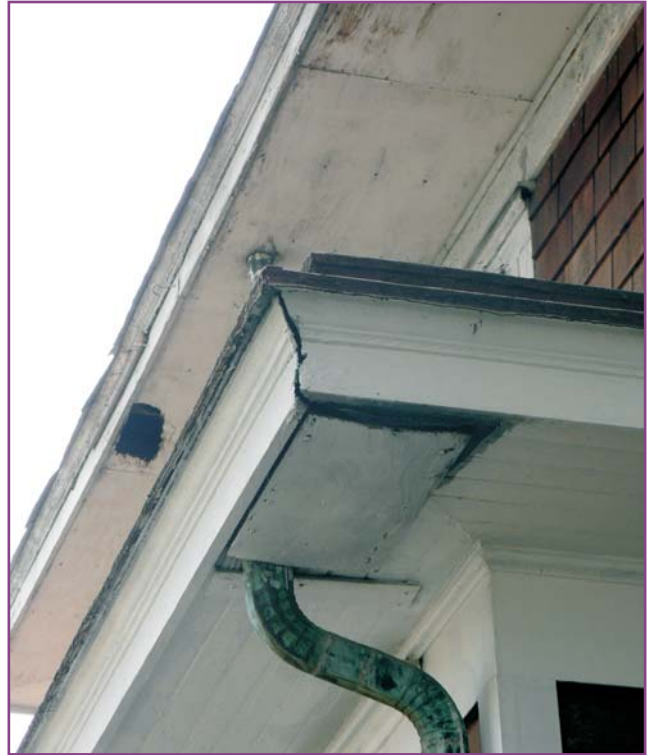
Photograph 29 of 46. Detail of bay and main soffits on northwest elevation (driveway side) showing moisture damage and need for woodwork repairs.

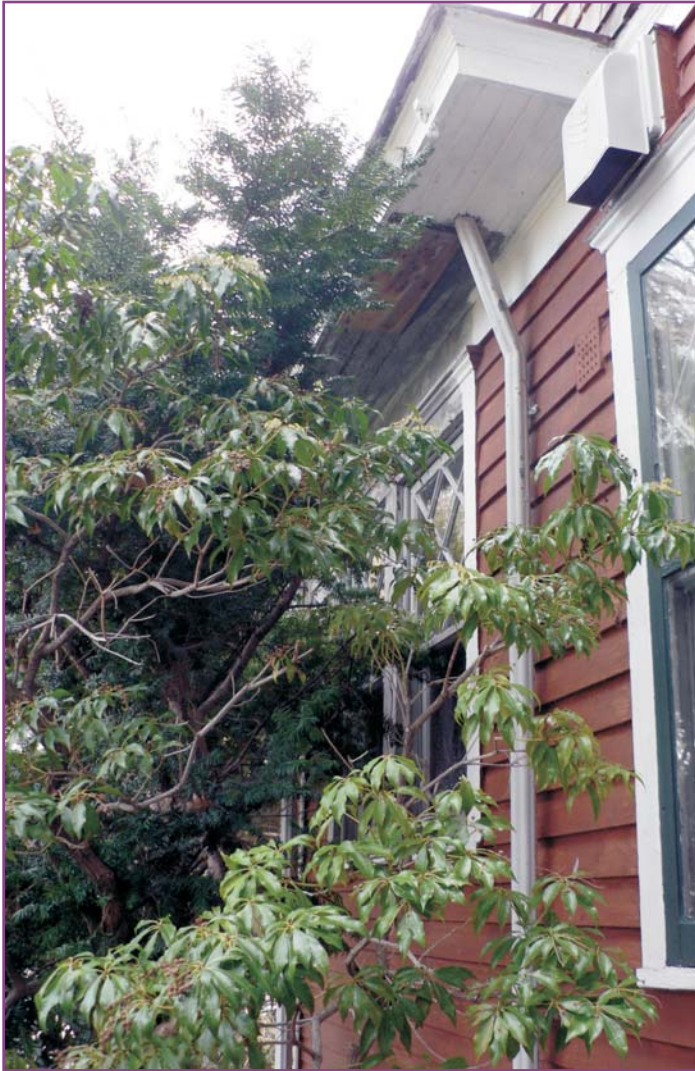
Photograph 30 of 46. Detail of the one story wall of the rear wing on the driveway (northwestern) side showing the encroachment of overgrown vegetation and corresponding deterioration of the woodwork due to the moisture held against the wall by the shrubbery.

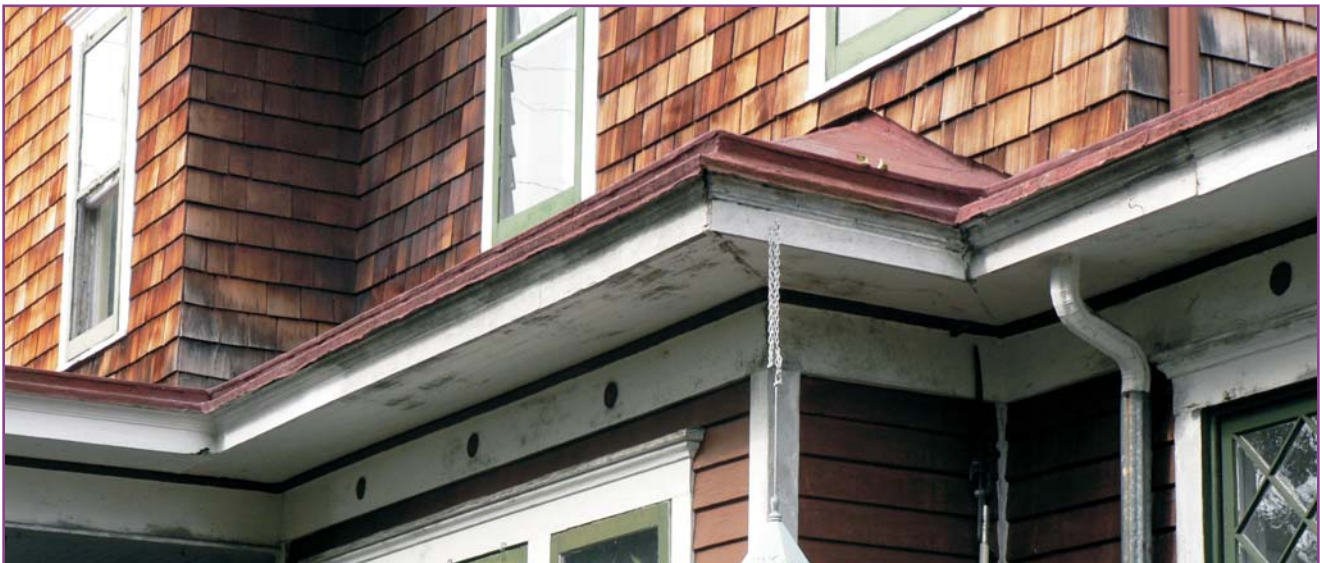
Photograph 31 of 46. Detail of the dining room box bay on the Stanfill Tower (southeastern) side. Similar to the porch, it is roofed in flat seam metal that will hold up indefinitely as long as its paint coat is well maintained.

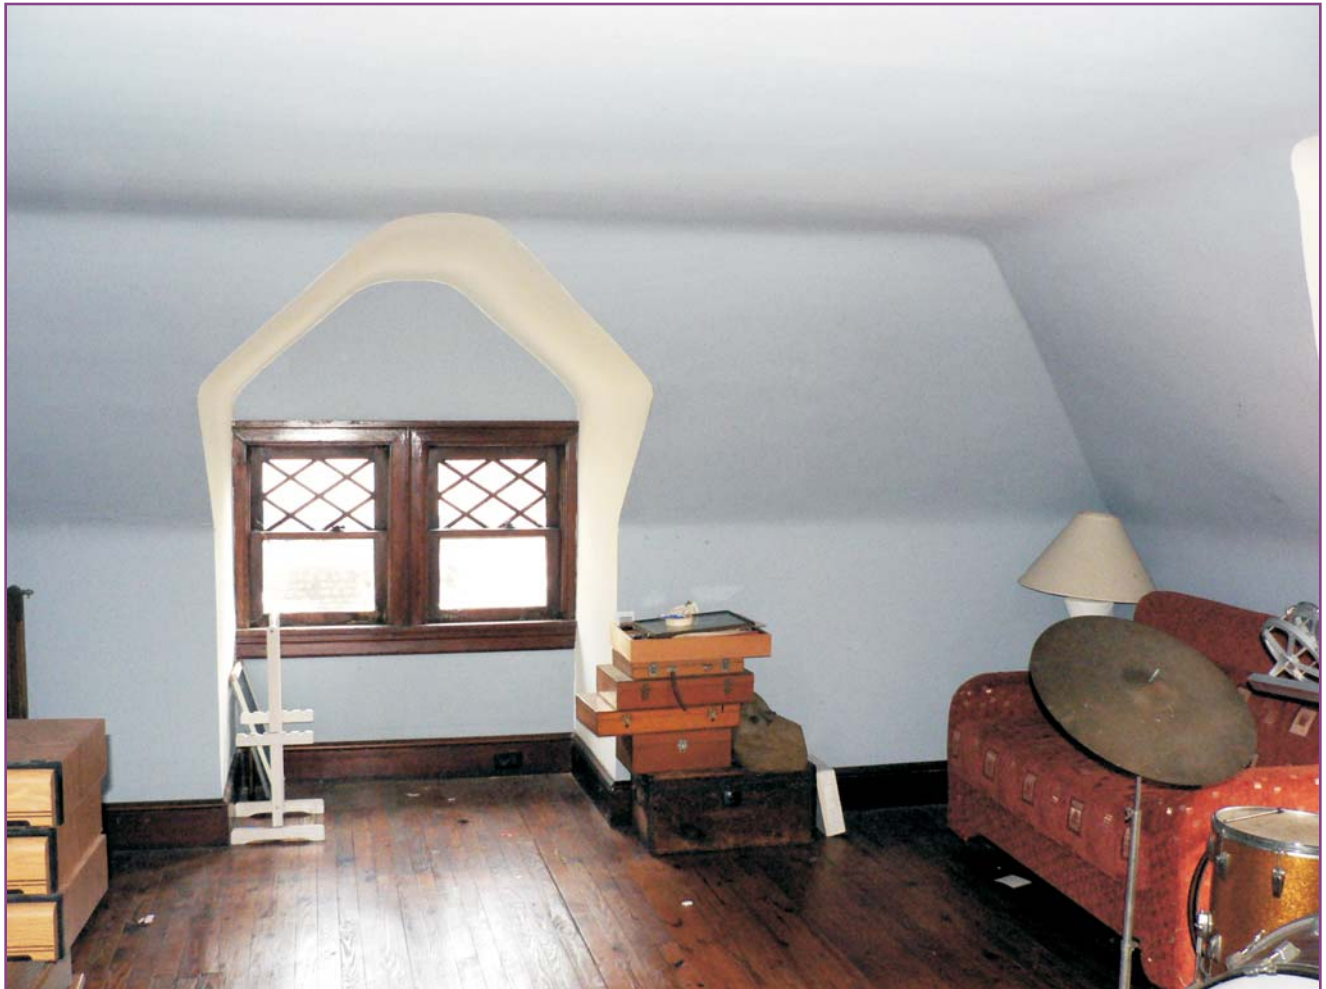
Photograph 32 of 46. Overall view of attic, facing northeast towards the rear dormer. Note that the paint and plaster is unstained under the field of the roof; however, it is likely that the inaccessible eave spaces (behind the knee walls) have been damaged by water infiltration, based on the exterior roof conditions at the deteriorated and clogged pole gutters.

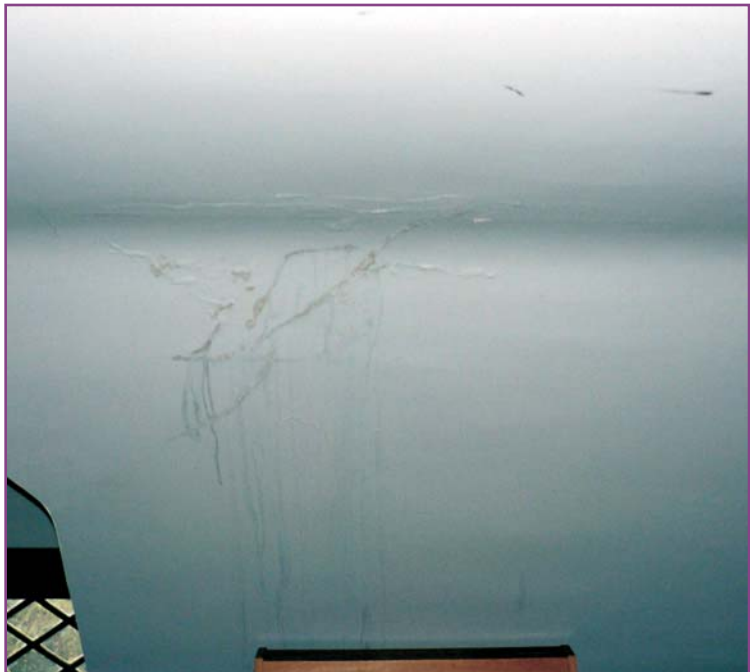
Photograph 33 of 46. View of the southeastern wall (Stanfill-Towers side) of the attic showing an old stain from a roof leak.

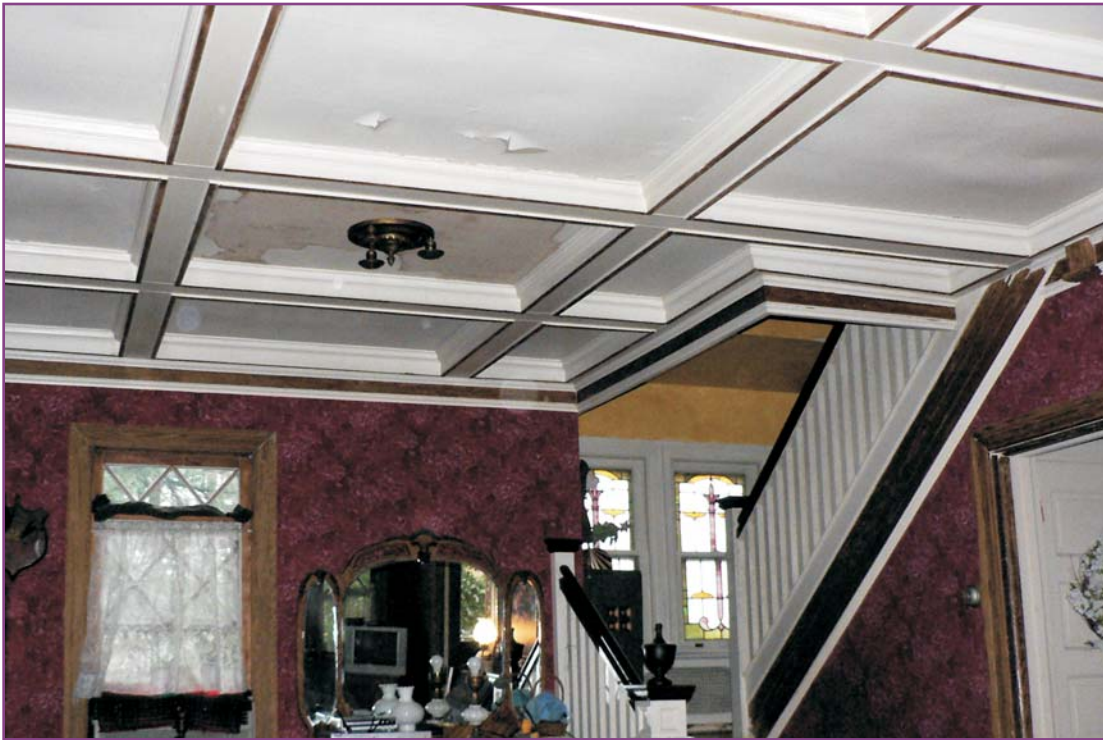
Photograph 34 of 46. View of first floor living room showing coffered ceiling. There is significant paint peeling on this ceiling; however it appears to be an aesthetic issue due to the paint's age, not a sign of water infiltration.

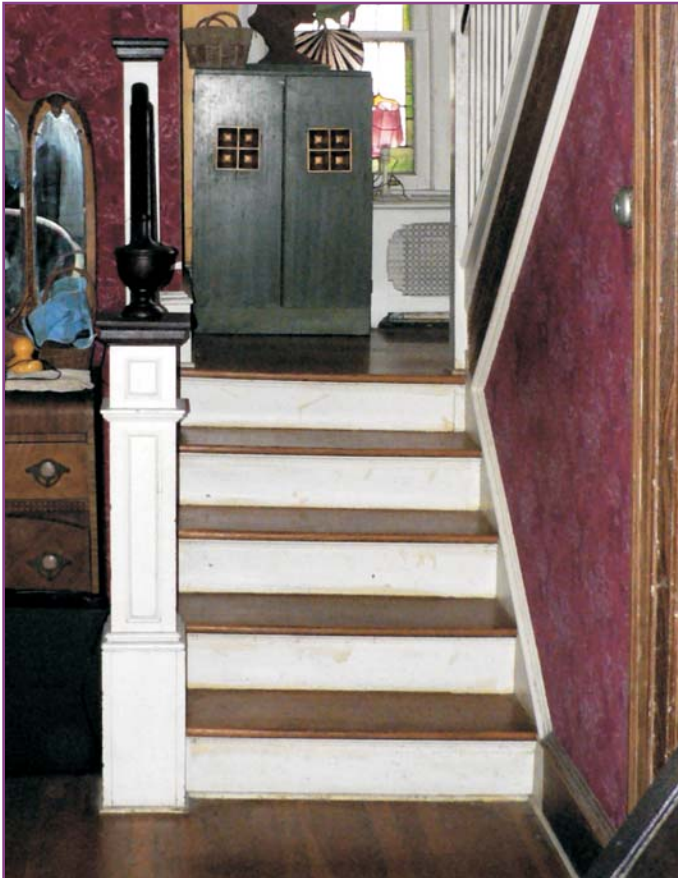
Photograph 35 of 46. Detail of living room stairs showing settlement of steps towards the center wall. There is a corresponding depression of the floor in the adjacent music room. Both are the result of the failed beam shown in basement photographs 40 and 41.

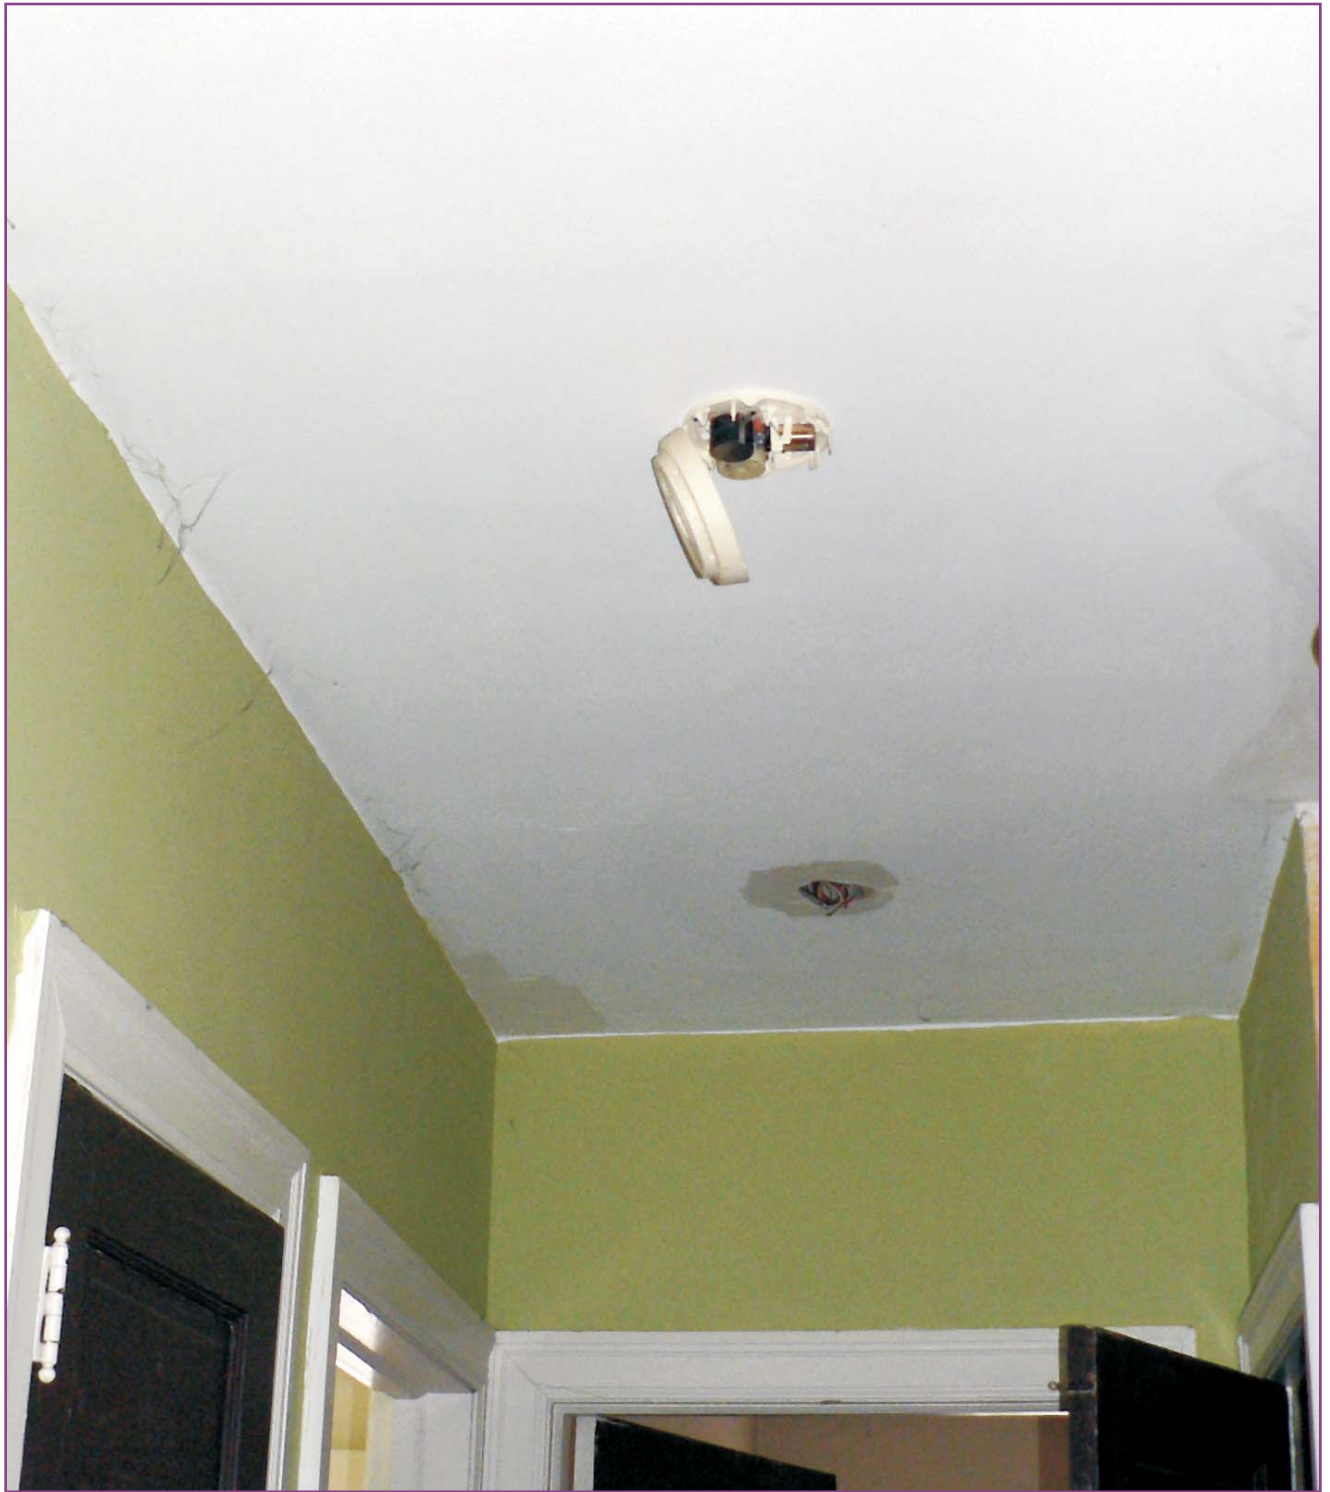
Photograph 36 of 46-View of the ceiling of the second floor hallway showing disabled smoke detector and open junction box for ceiling light fixture. There are similar conditions in the dining room, music room (space beside first floor

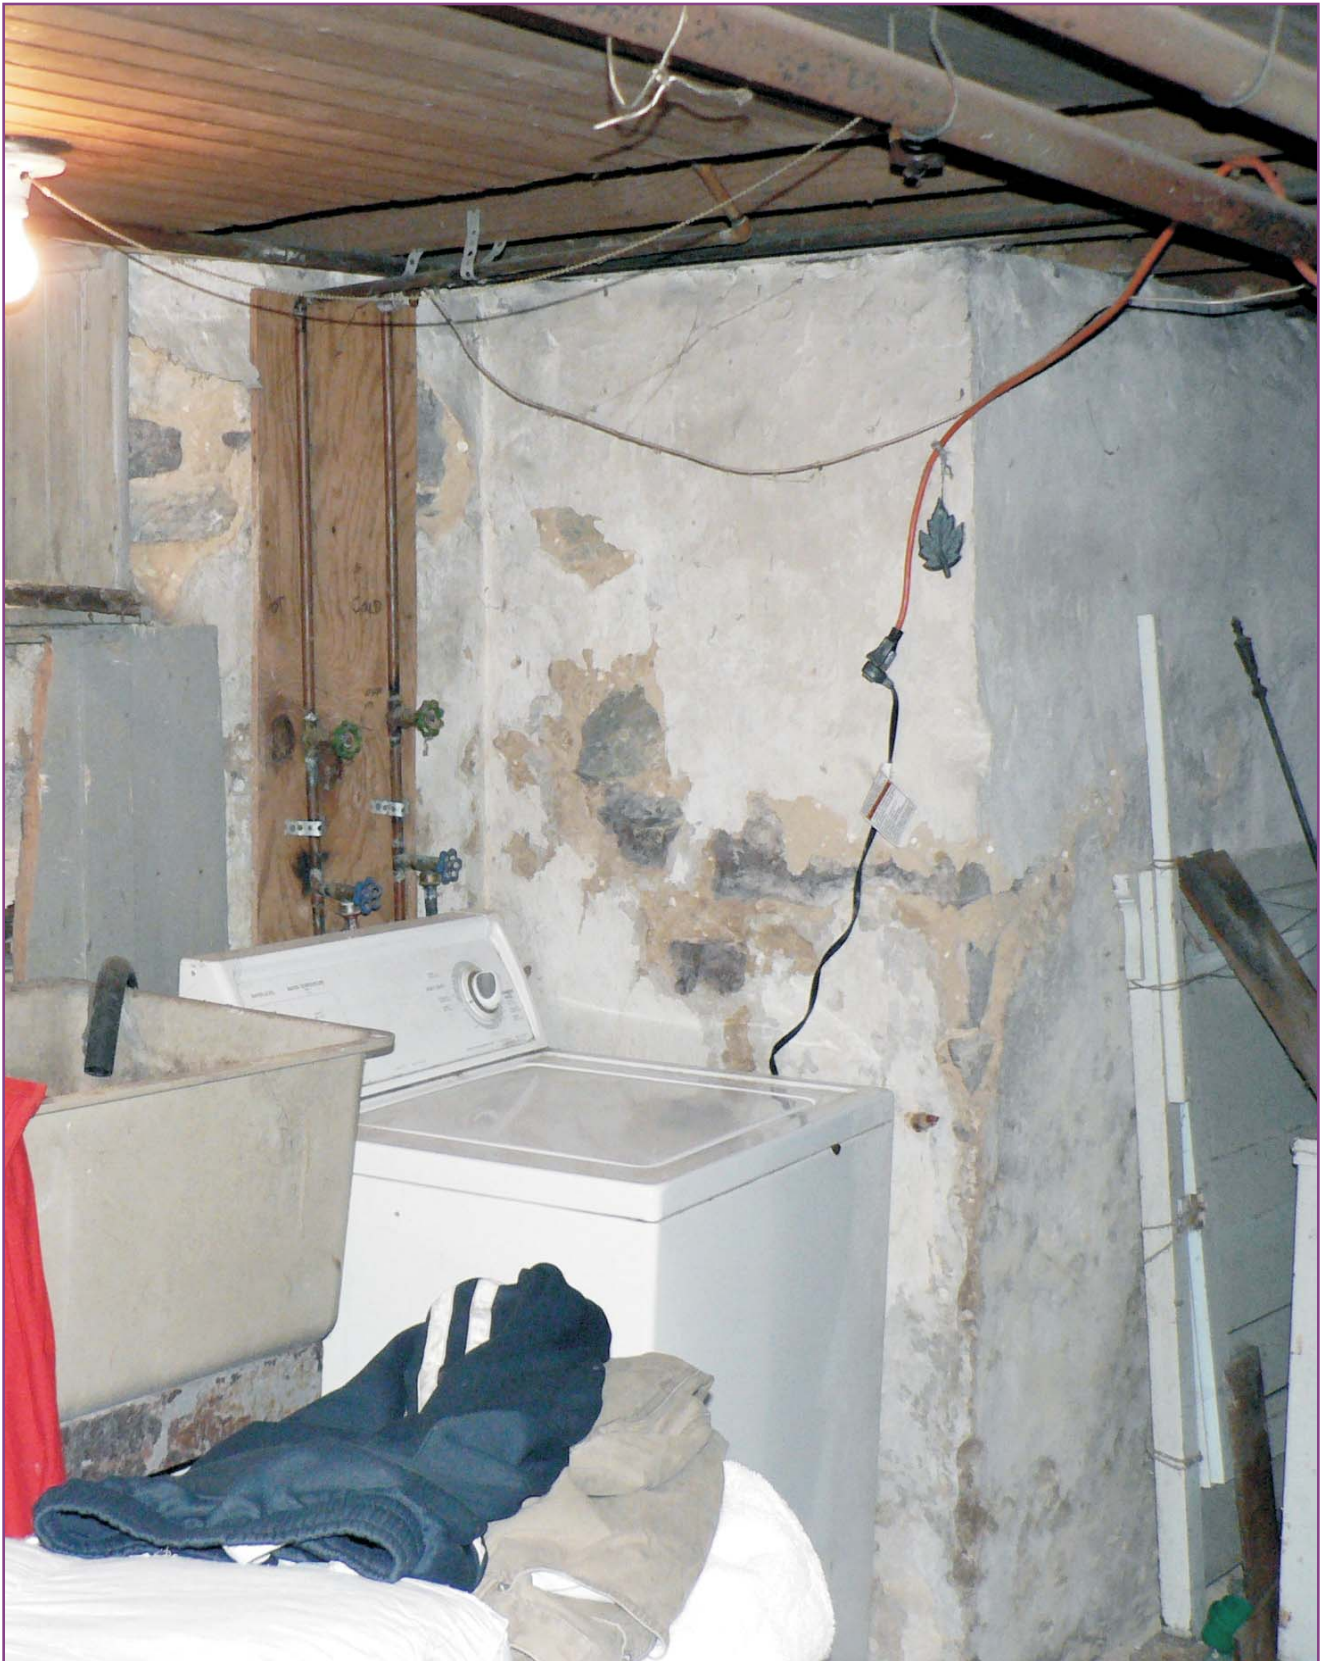
Photograph 37 of 46. Detail of southeastern foundation wall to the rear of the fireplace support showing moisture damage from the chimney leak nearly 30' above, and unsafe use of an extension cord to power the washing machine.

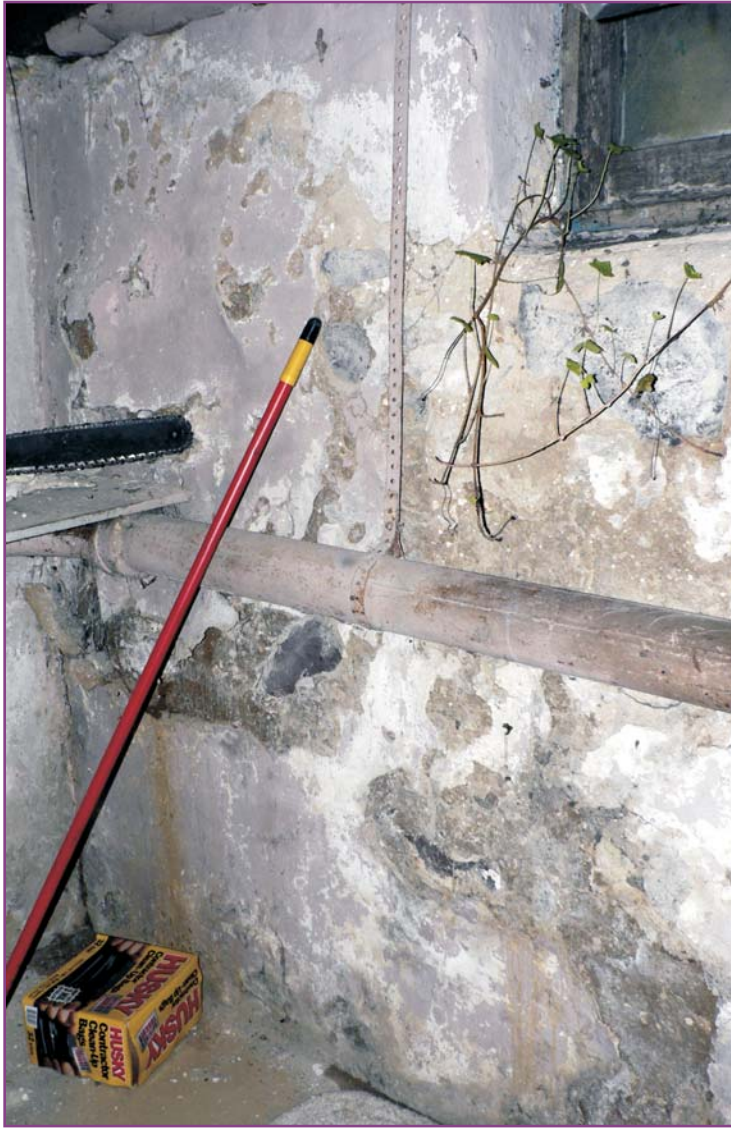
Photograph 38 of 46. Detail of the basement's northern corner showing vegetation entering through the three-light sash basement window and efflorescing moisture damage to the plastered stone foundation walls.

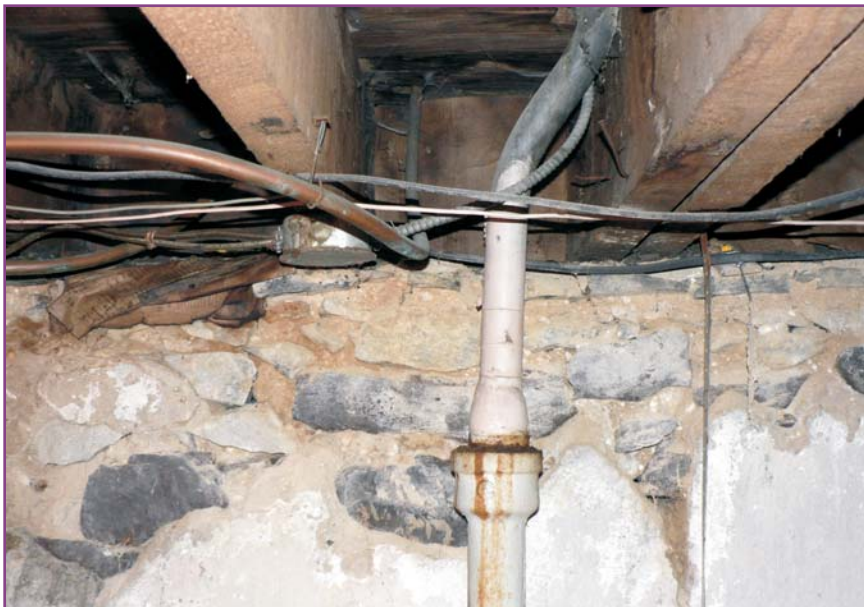
Photograph 39 of 46. Detail of typical area of moisture damage at the top of the foundation walls. Both the plaster and the mortar joints have deteriorated, and the wood framing is stained.

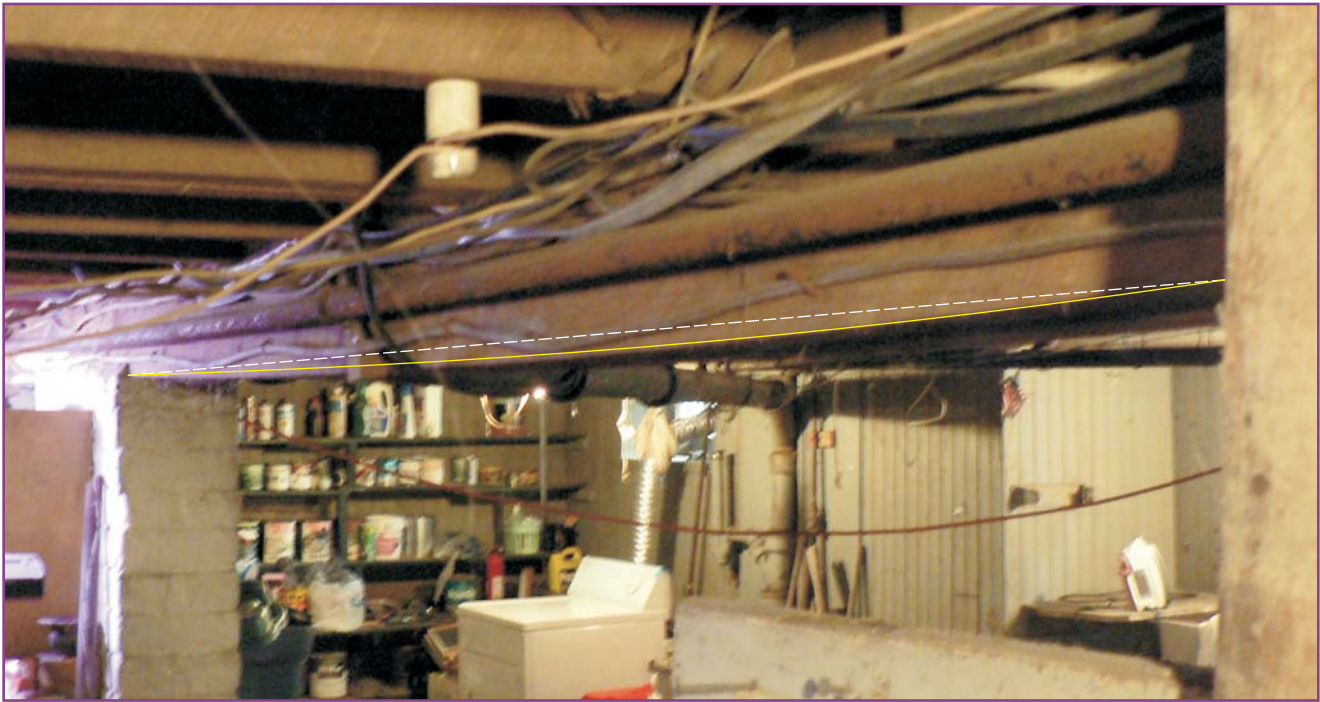
Photograph 40 of 46. View of central structural girder. Note deflection indicated by yellow line. (The white line shows where the bottom of the girder would be if it were level.)

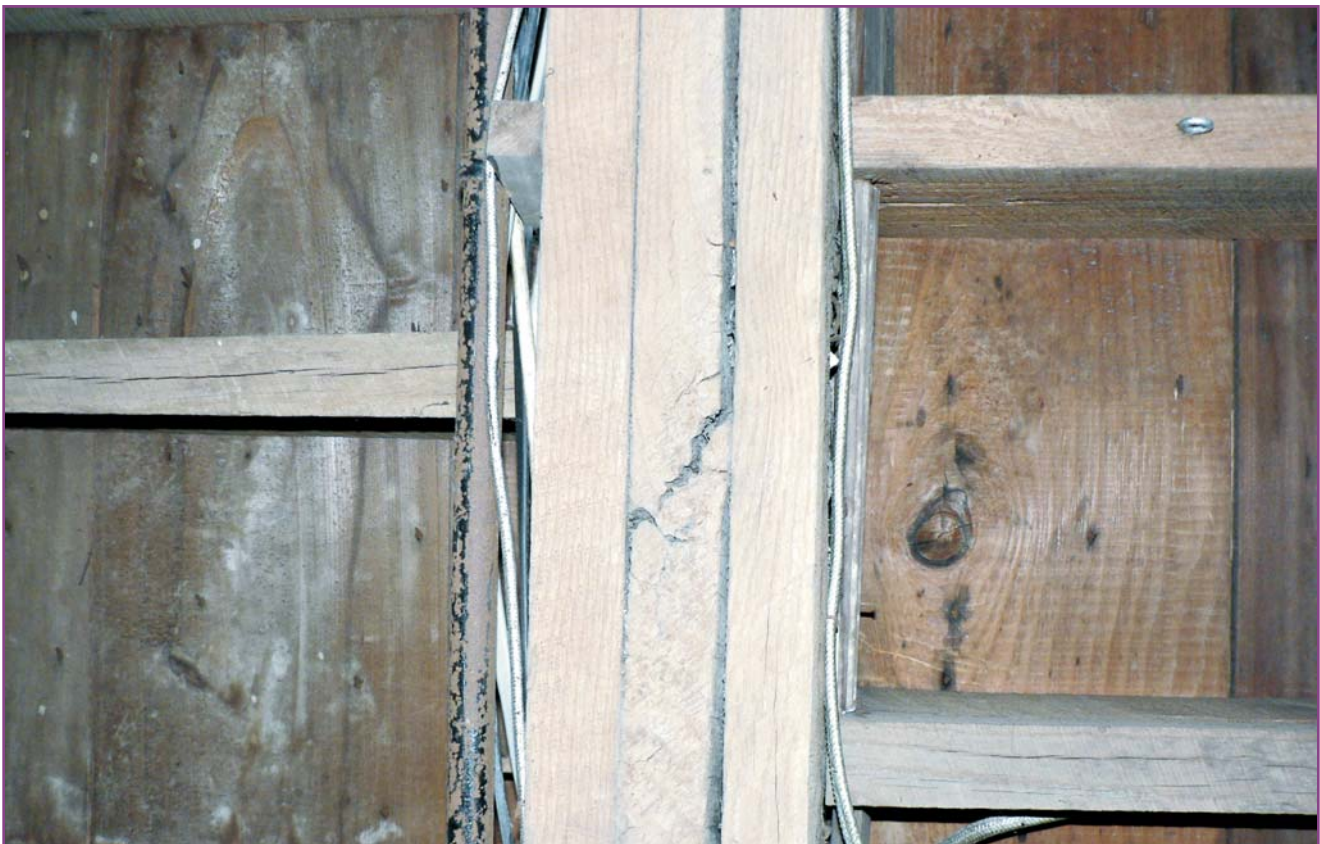
Photograph 41 of 46. Detail of partially failed central built-up girder.

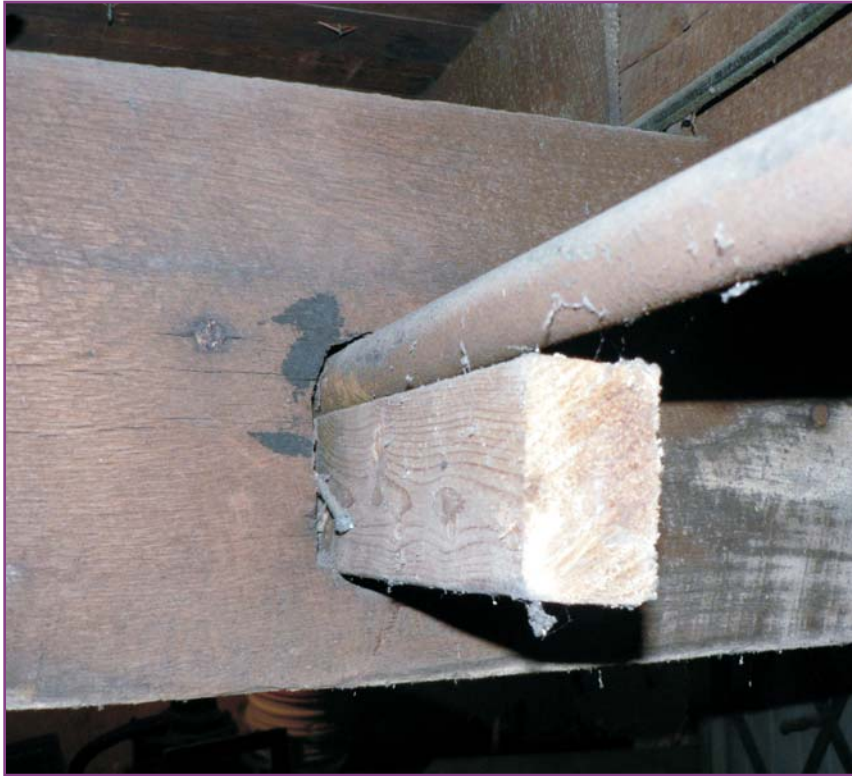
Photograph 42 of 46. Detail of altered support beam in basement that has had its bearing capacity compromised by the plumbing installation.

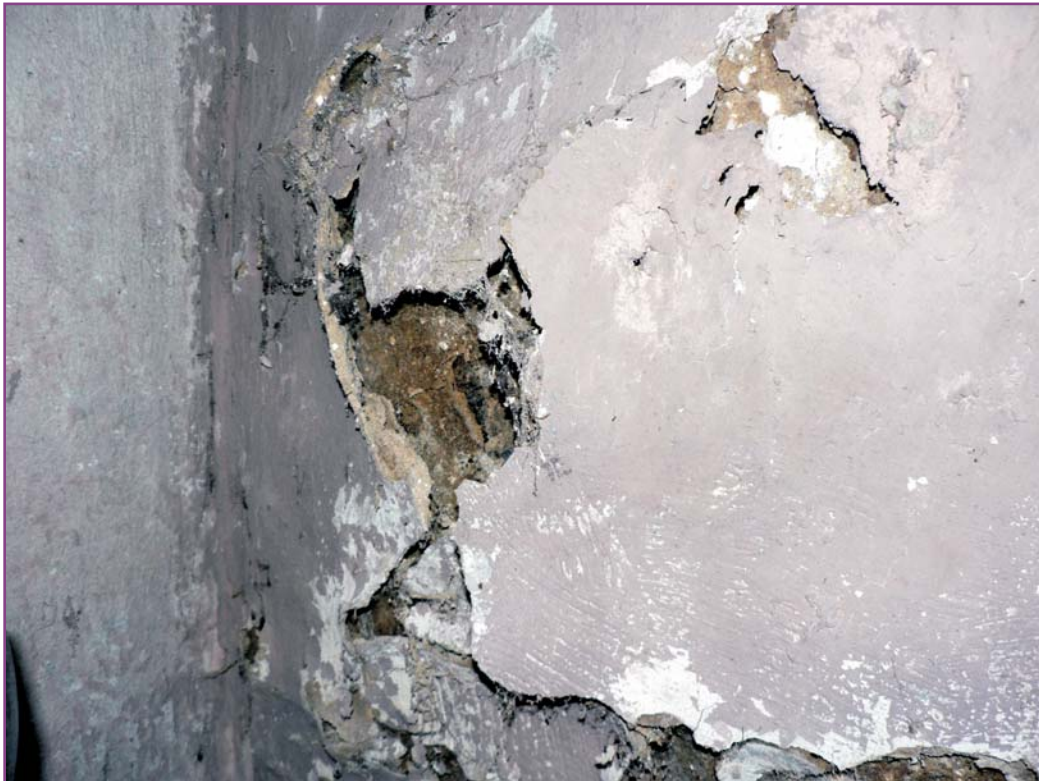
Photograph 43 of 46. Detail of exfoliating plaster caused by water entering the basement foundation walls.

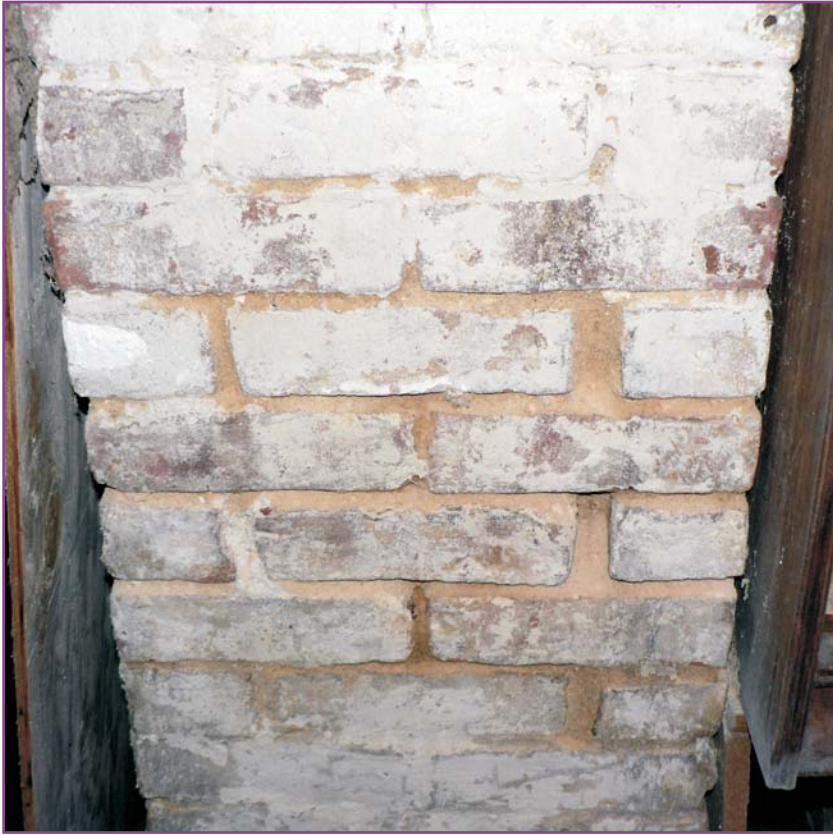
Photograph 44 of 46. Detail of typical brick pier in basement in need of spot repointing.

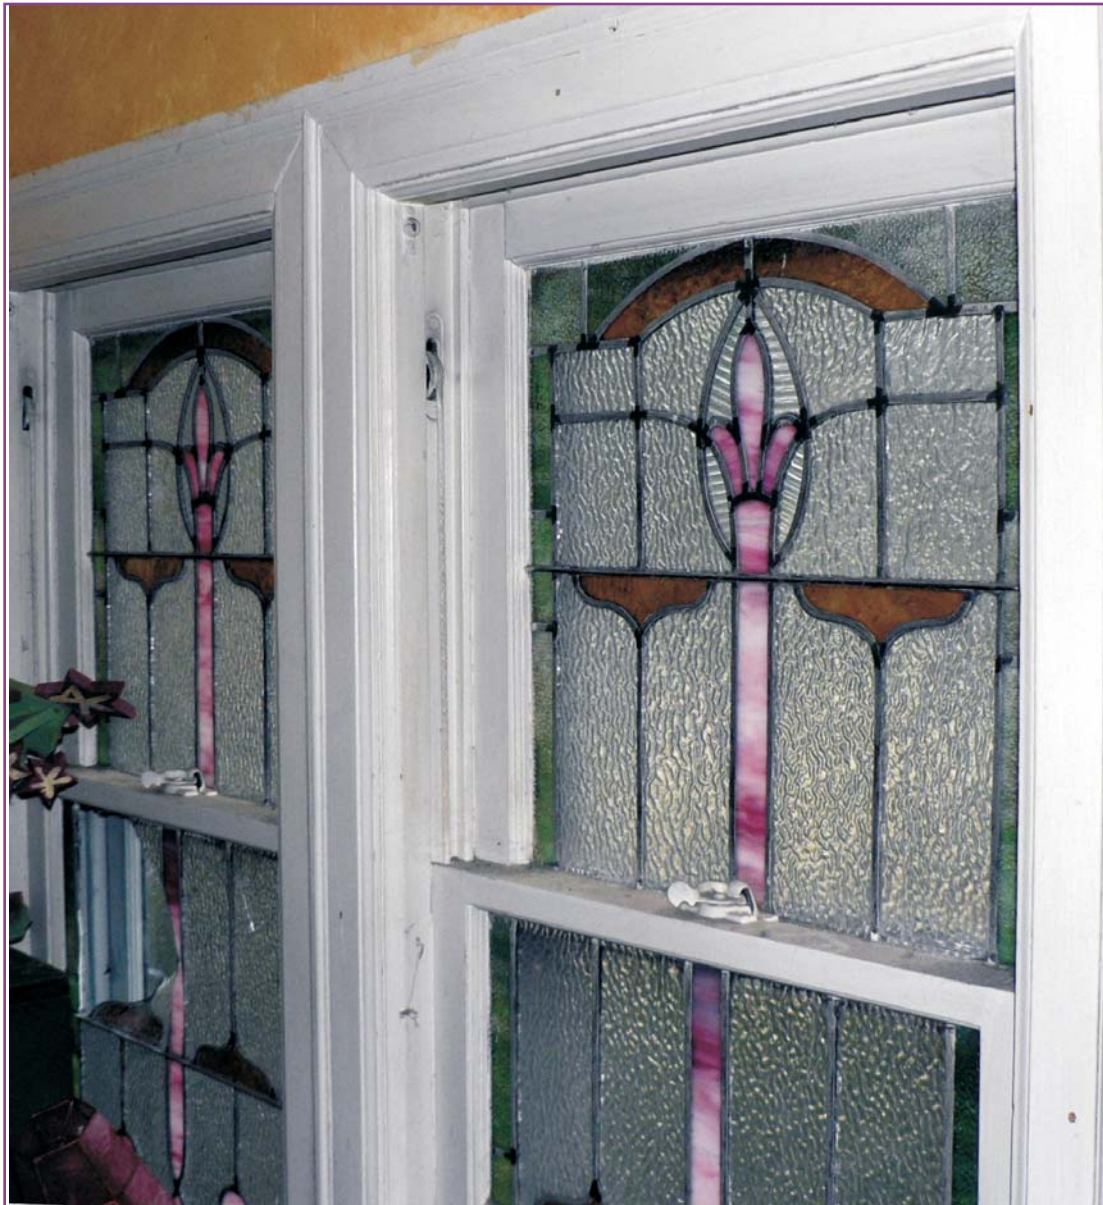
Photograph 46 of 46. Detail of two of the three stained glass windows on the stair landing showing broken section in lower left sash and cracked pane in lower right sash. Note that the intact sash cords on both windows. These sash cords are connected to sash weights hidden inside the window frame that counter balance the bottom sash when the window is opened.
